Field Observation Report #6

Date:	<u>August 2, 2013</u>	Project:	<u>Burleigh County Shop</u>
Time:	<u>1:30pm</u>	Project No:	<u>12-04</u>
Weather:	<u>Sunny / Slightly Windy</u>	Location:	<u>Bismarck, ND</u>
Temperature:	<u>80 degrees</u>		
% Complete:	<u>6% Visible</u>		
Trades:	<u>Dirtwork</u>		
Crew Size:	<u>4-6</u>

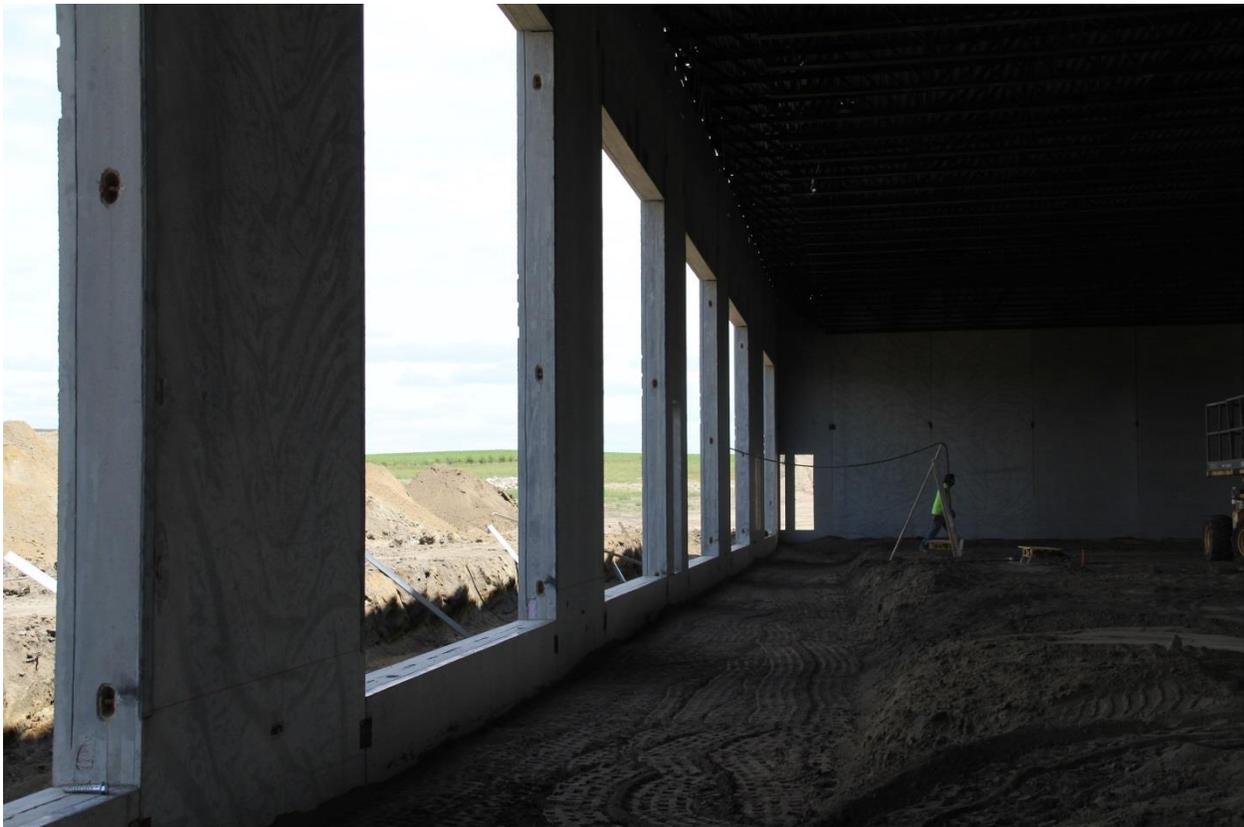
Photo 1: view from interior of west wall, Area "A"

1. The roof deck and roof drains have been placed for Area "A". Dirt work, in particular backfilling, is taking place in and around Area "A" (please see *Photo 1 & Photo 4*).

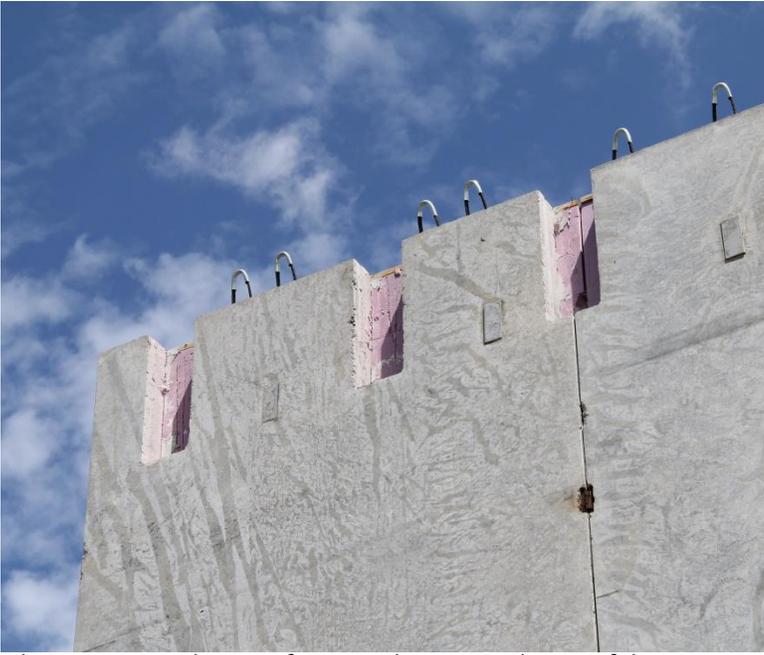
Photo 2: joist pockets run from joist bearing to the top of the parapet.

2. Capital City Construction is currently pricing the addition of insulation to the joist pockets in the pre-cast panels. This addition will reduce the opportunity for transmission of cold air at joist locations. Please see *Photo 2* for an image of these joist pockets. The notches will be filled to the parapet top (top of pre-cast) with either rigid or batt insulation.

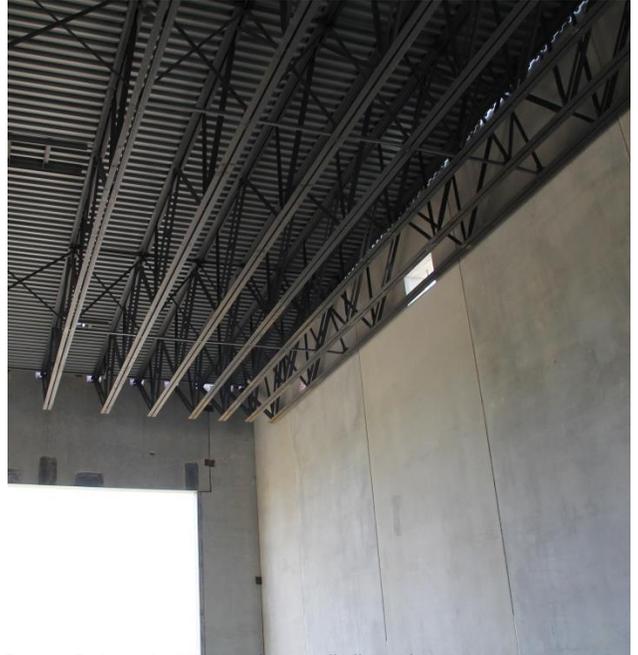
Photo 3: interior view of Area "A" roof construction @ SE corner

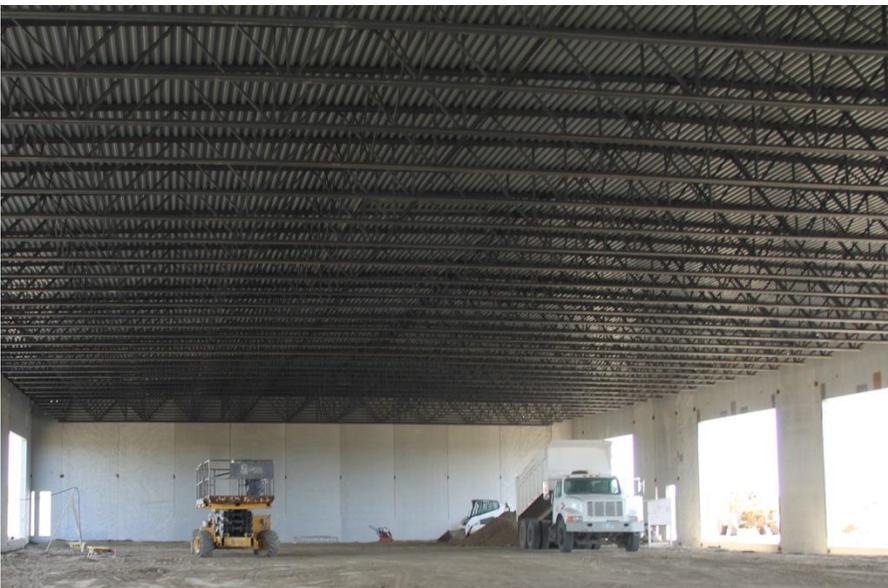
Photo 4: interior view of completed roof deck in Area "A"

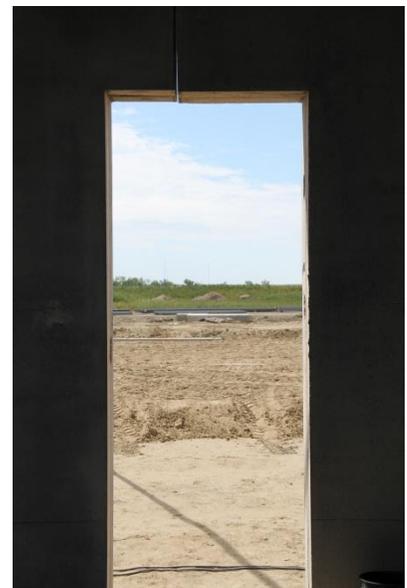
Photo 5: precast door opening

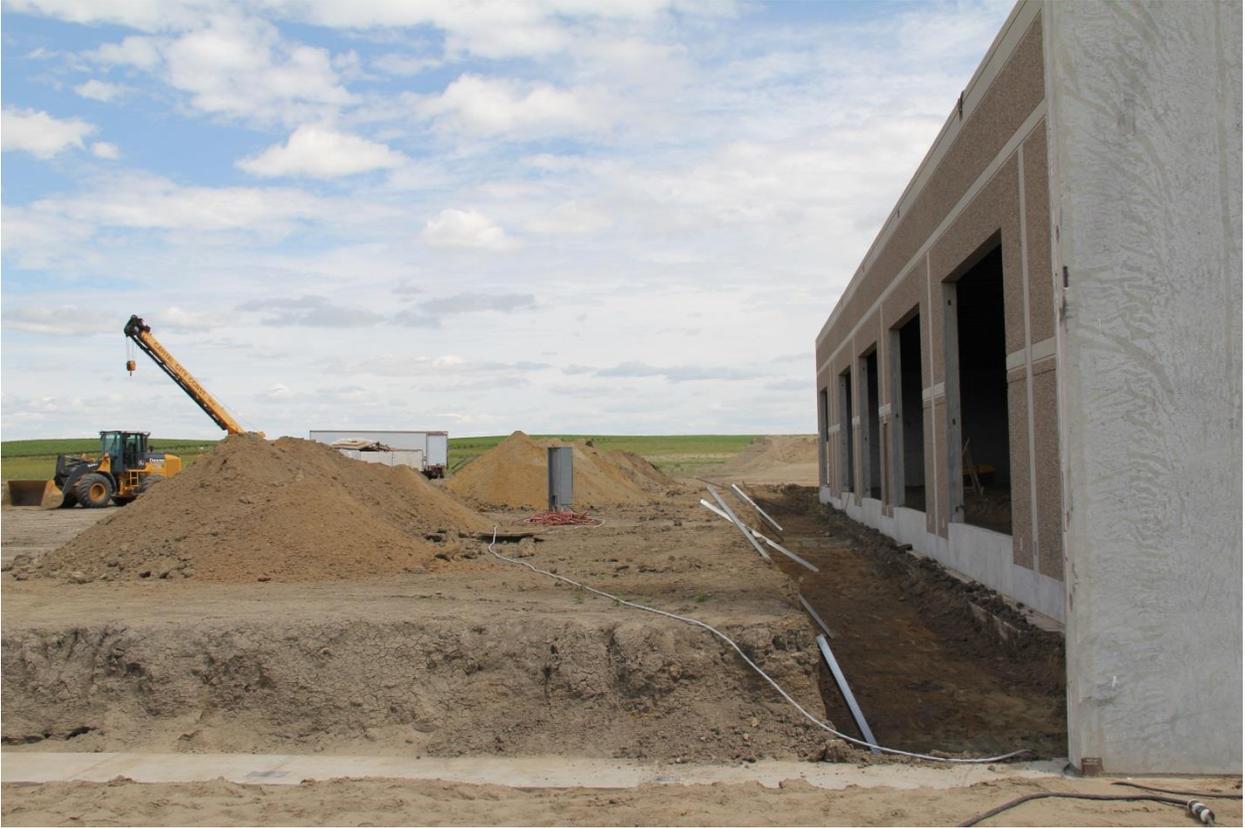
Photo 6: exterior view along west edge of Area "A"
