## Field Observation Report #10

Date:	<u>October 24, 2013</u>	Project:	<u>Burleigh County Shop</u>
Time:	<u>2:45 pm</u>	Project No:	<u>12-04</u>
Weather:	<u>Sunny</u>	Location:	<u>Bismarck, ND</u>
Temperature:	<u>50 degrees</u>		
% Complete:	<u>40% Visible</u>		
Trades:	<u>Masonry Work</u>		
Crew Size:	<u>5-8</u>

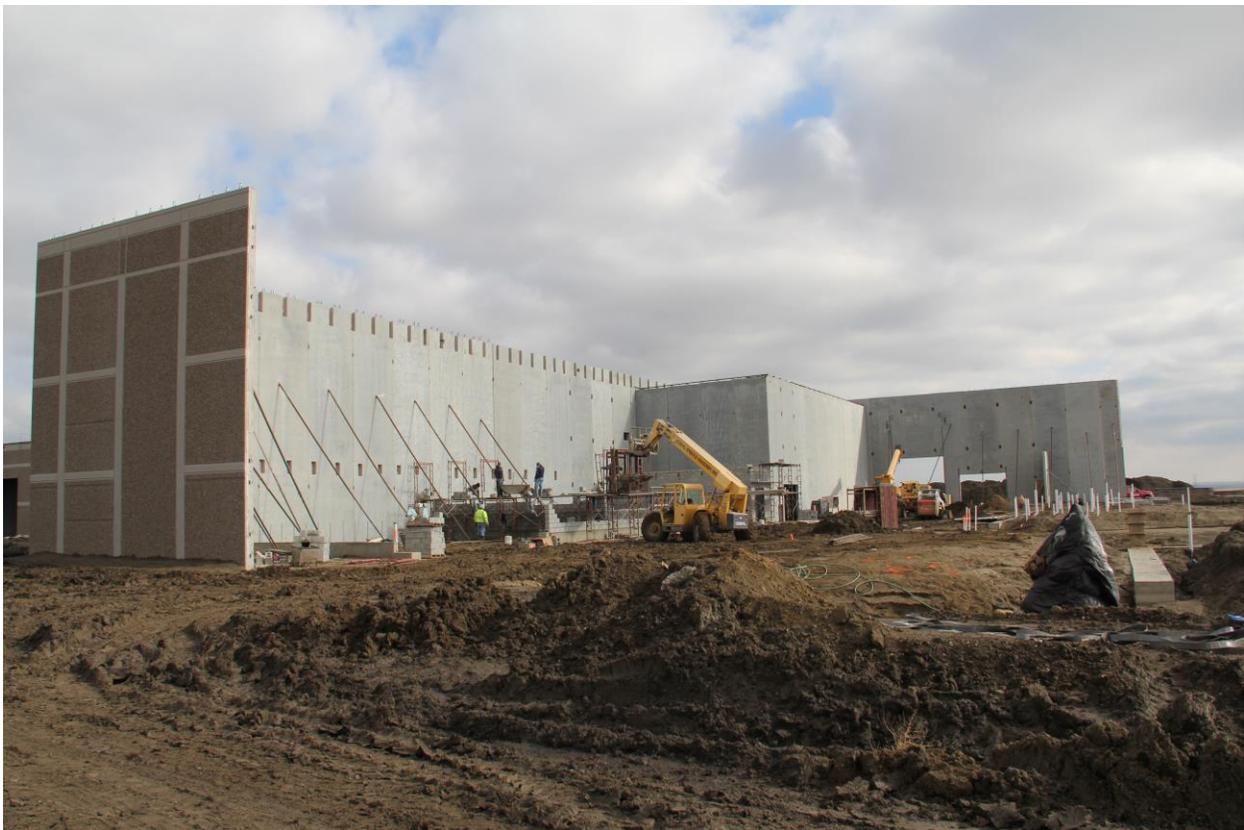
*Photo 1: The Welding Bay has been enclosed with pre-cast panels; masonry work continues in Area B & C.*

1. Construction has slowed down due to the amount of moisture on-site. Mud is making it difficult to bring-in trucks to place pre-cast panels. Capital City Construction is hoping for some consecutive days without moisture to allow for the delivery and placement of the panels. The panels themselves are all constructed and ready for delivery (*please see photo 1*).

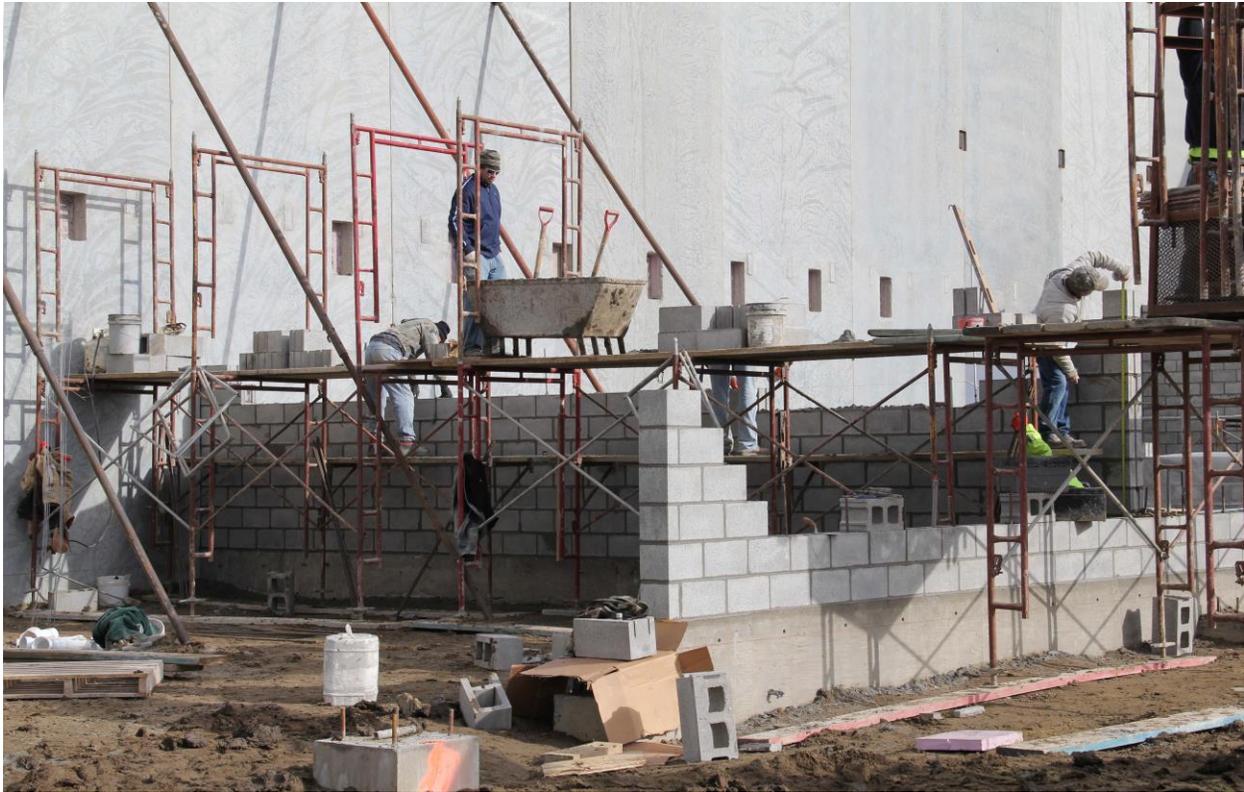
Photo 2: Masonry construction is underway in Area B & C.

2. CMU blocks are being set around Sign Storage 128, Office 129 & Parts 131 (please see photo 2 & 3).

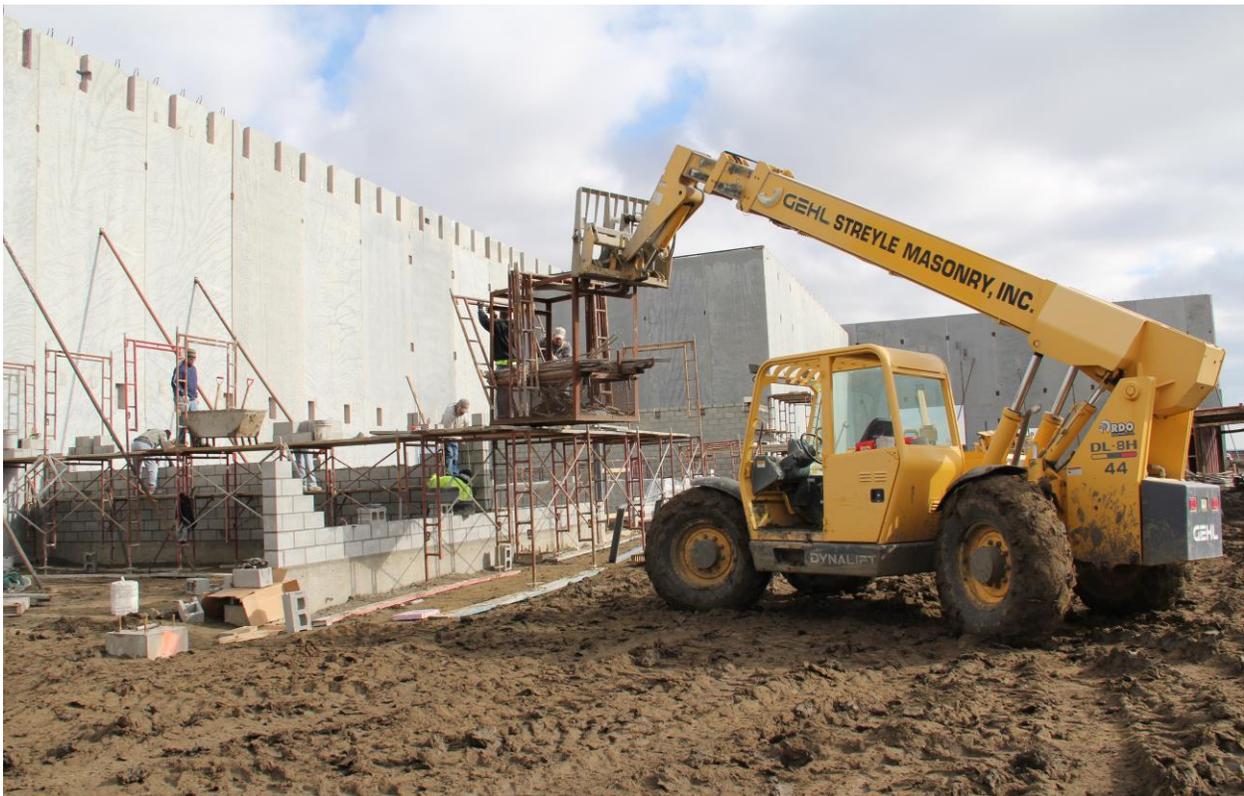
Photo 3: Masonry construction is underway in Area B & C.

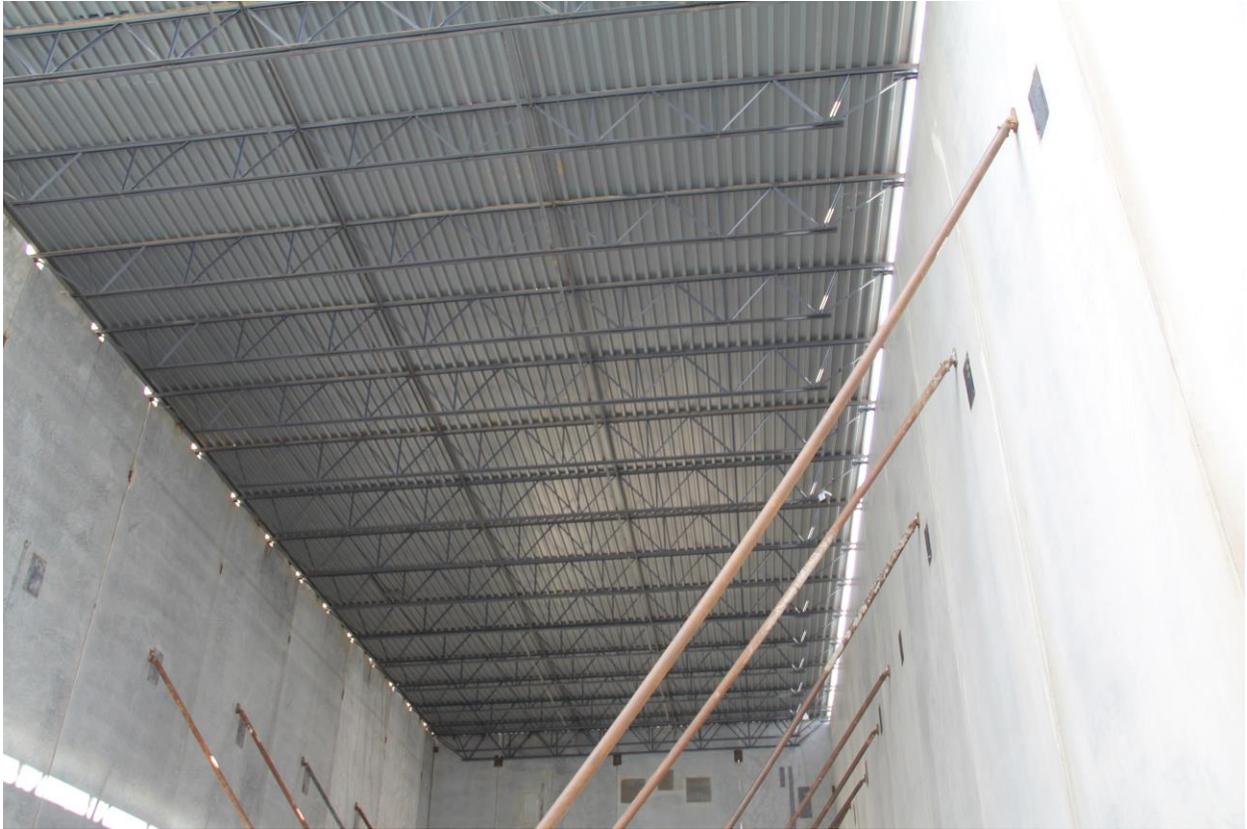
*Photo 4: The joists and deck have been placed in the welding bay.*

3. Roof joists and metal deck have been placed on the majority of the Welding Bay roof. The embed plates required to support the 2-Ton bridge crane are located along both long walls. The roof drain piping in the Welding Bay will have to drop along the north wall, within 15 feet of the exterior wall to avoid conflict with the bridge crane. This has been coordinated with City Air Mechanical (*please see Photo 4*).
