Field Observation Report #11

Date:	<u>November 7, 2013</u>	Project:	<u>Burleigh County Shop</u>
Time:	<u>2:45 pm</u>	Project No:	<u>12-04</u>
Weather:	<u>Sunny</u>	Location:	<u>Bismarck, ND</u>
Temperature:	<u>35 degrees</u>		
% Complete:	<u>43% Visible</u>		
Trades:	<u>Masonry Work</u>		
Crew Size:	<u>5-8</u>

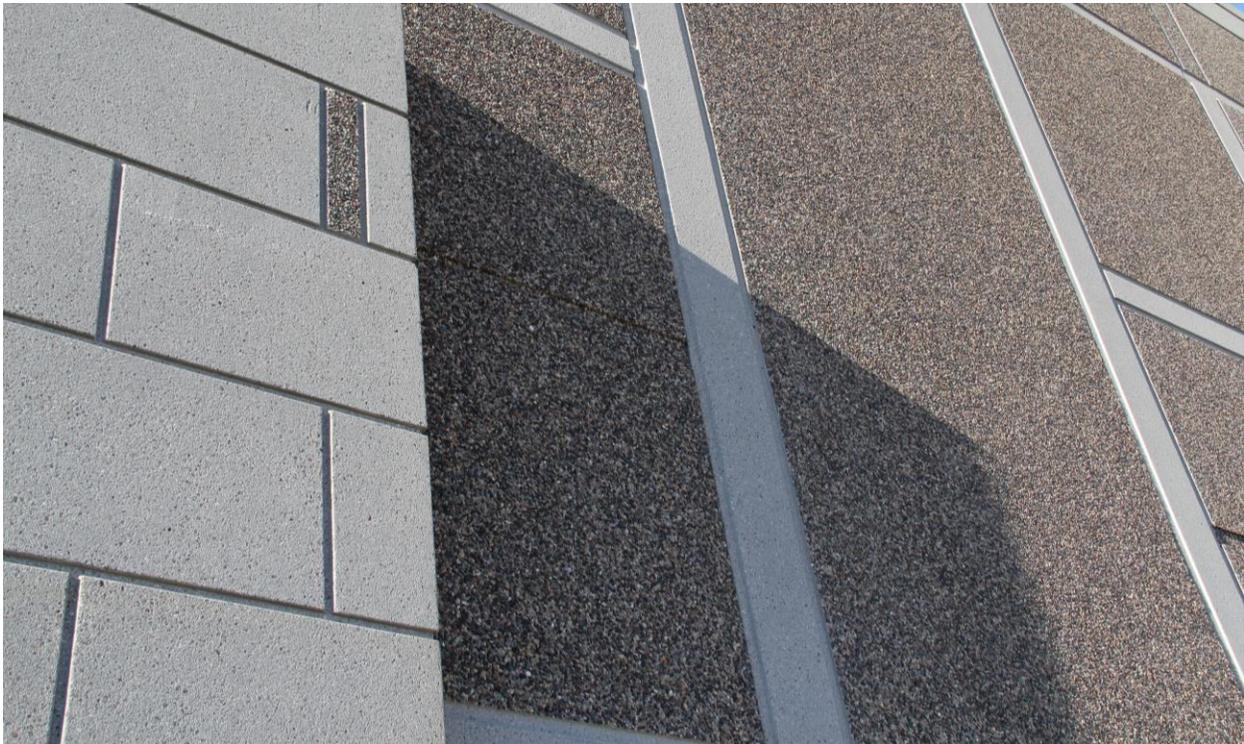
Photo 1: Transition between tall shop space and the lower administration area pre-cast panels.

1. Additional pre-cast panels have been placed; if weather cooperates, the remaining panels could be installed in two weeks' time. Several administration area panels have been placed as well. The estimated date of enclosure is the first of January 2014. (please see photo 1 & 2).

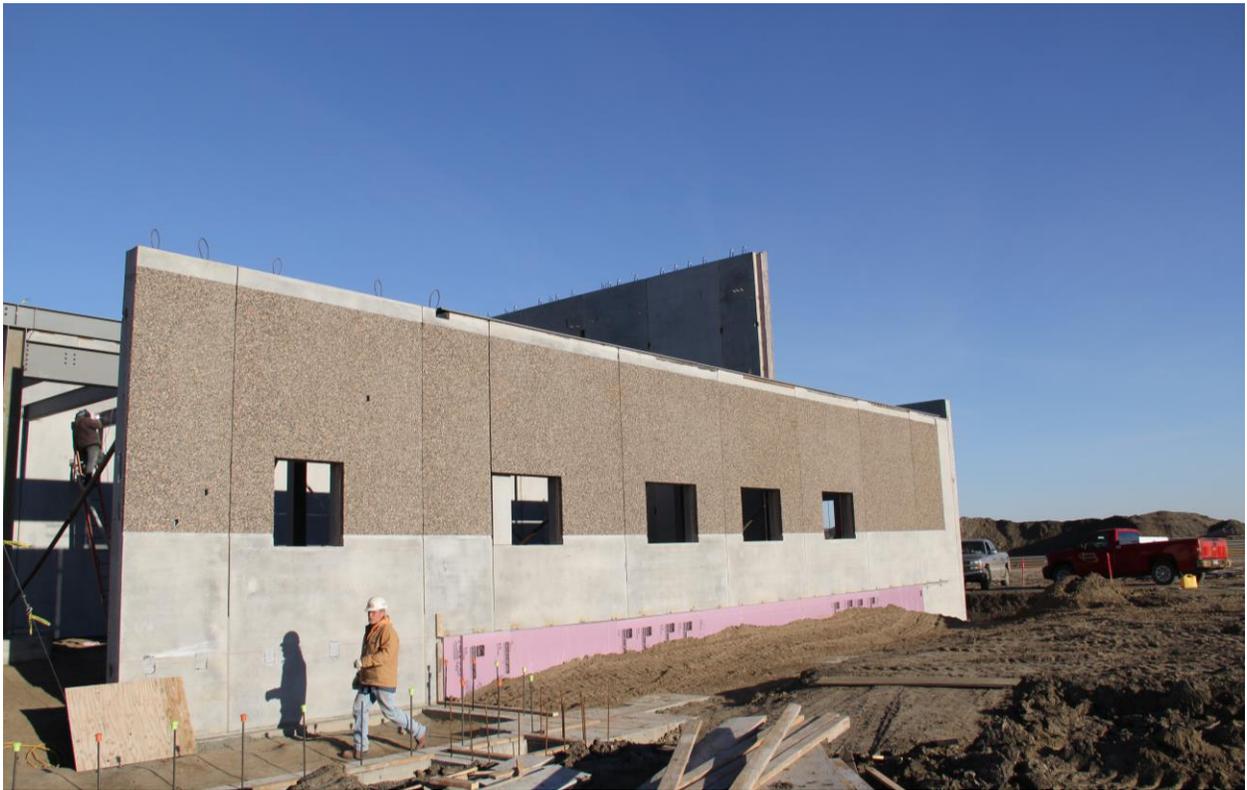
Photo 2: block veneer support angles and rigid insulation has been placed along part of the south elevation.

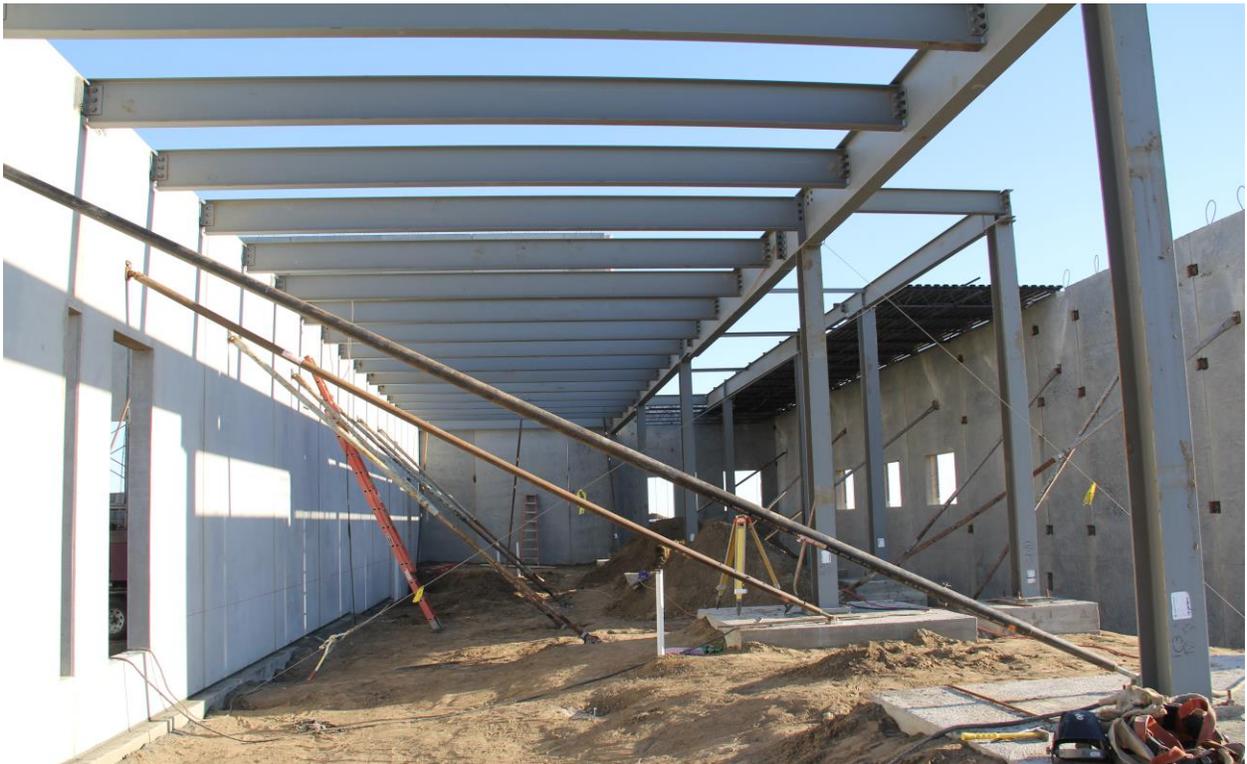
2. The steel roof/floor members and some deck has been placed in the administration area; the lower structural columns have been placed for the raised roof area at the administration hallway (*please see photo 3*).

Photo 3: Structural steel erection is underway in administration; the beams shown support the mezzanine above.

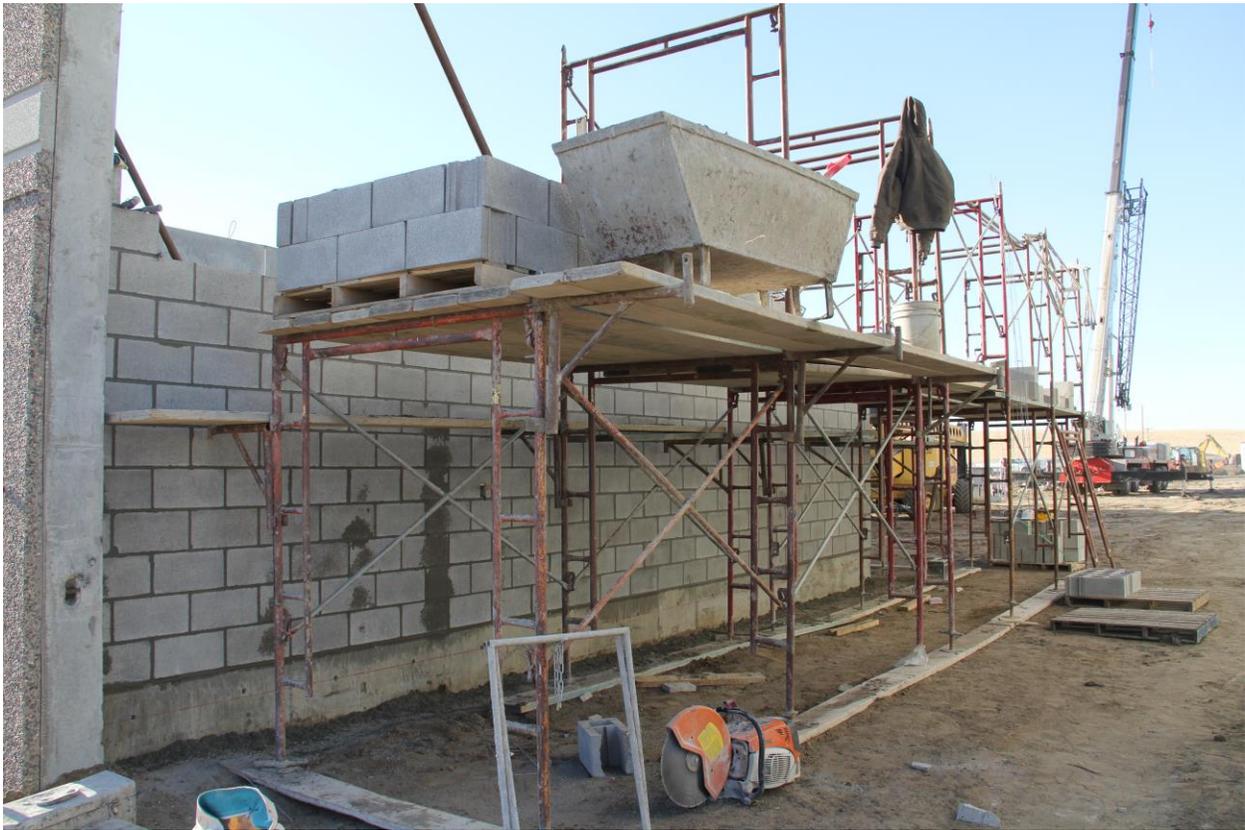
Photo 4: Surveying Bay masonry construction.

3. Masonry work continues around the surveying bay (*please see Photo 4*).
