Field Observation Report #13

Date:	<u>December 5, 2013</u>	Project:	<u>Burleigh County Shop</u>
Time:	<u>2:45 pm</u>	Project No:	<u>12-04</u>
Weather:	<u>Sunny</u>	Location:	<u>Bismarck, ND</u>
Temperature:	<u>0 degrees</u>		
% Complete:	<u>58% Visible</u>		
Trades:	<u>n/a</u>		
Crew Size:	<u>1</u>

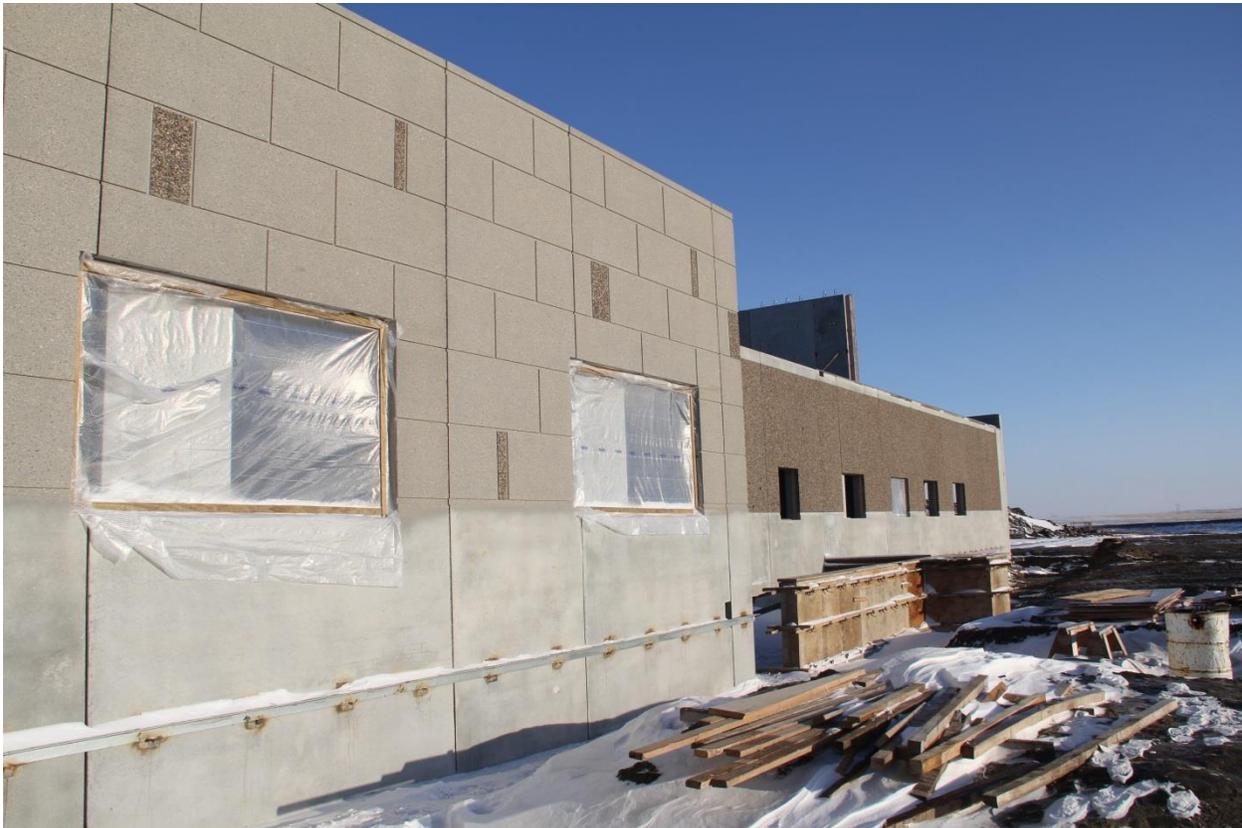
Photo 1: Pre-Cast Panel Progress has been made around Area "C".

1. Additional pre-cast panels have been placed around the admin area. Panels remain above the south mezzanine and around the entrance / entry canopy. The area below windows in the admin area will be covered with burnished block, the burnished block support angles have been installed (*please see photo 1*).

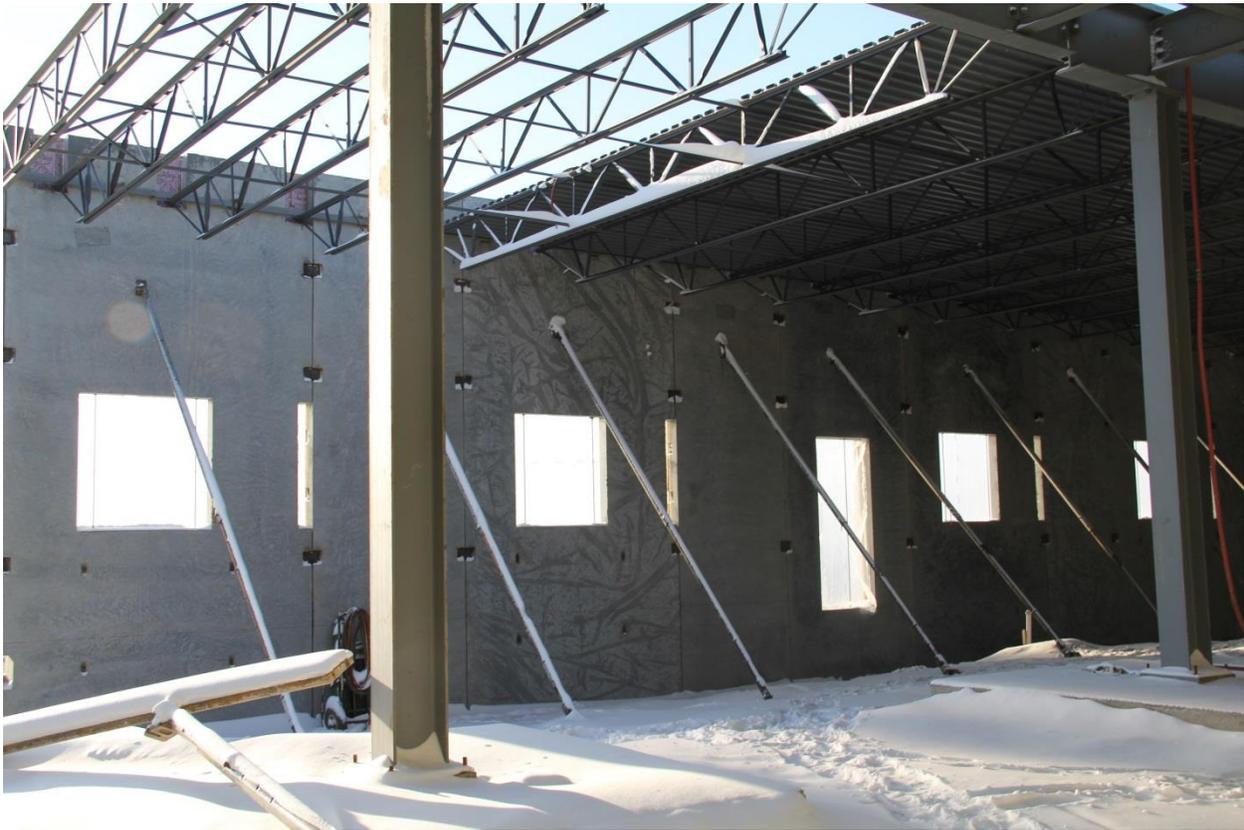
Photo 2: Area "B" & "C" bar joist and roof deck over the admin area is being placed

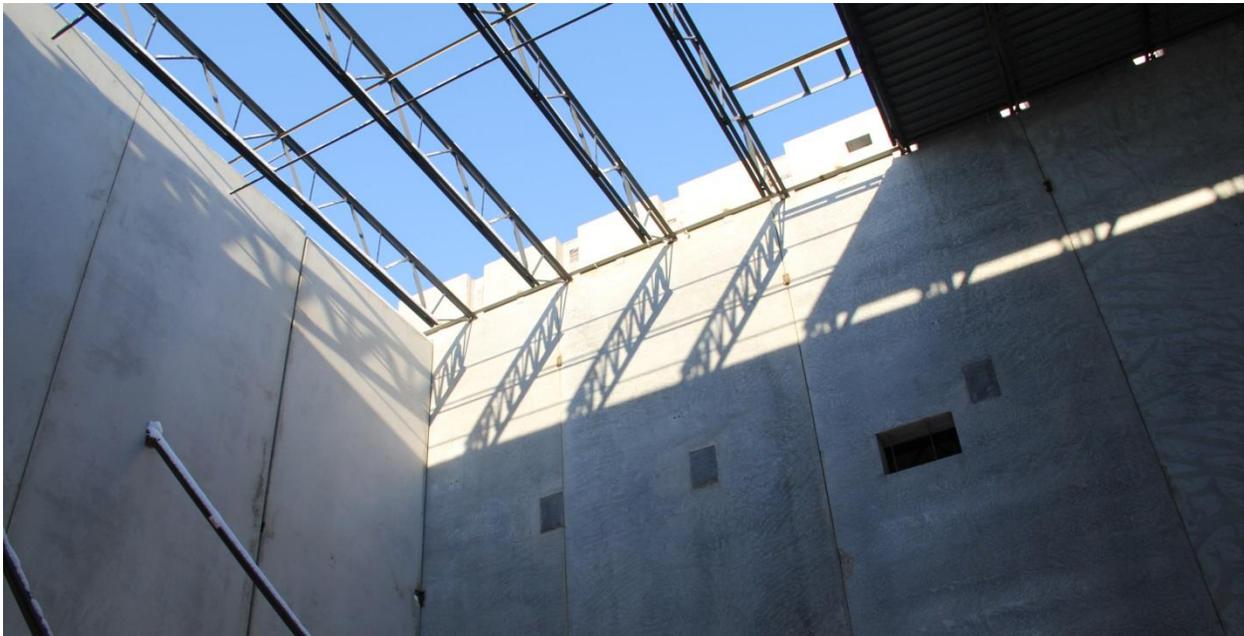
Photo 3: Welding Bay, HVAC opening was confirmed to be lower than the bridge crane embed plates.

2. Questions were raised in the construction meeting regarding HVAC runs in conflict with the welding bay bridge crane. After the meeting, City Air Mechanical, Beazley Engineering and Ubl Design Group visited the Welding Bay to confirm that the openings in the pre-cast for the welding equipment exhaust were located below the bridge crane, to avoid conflict. The openings were placed correctly (please see Photo 3).

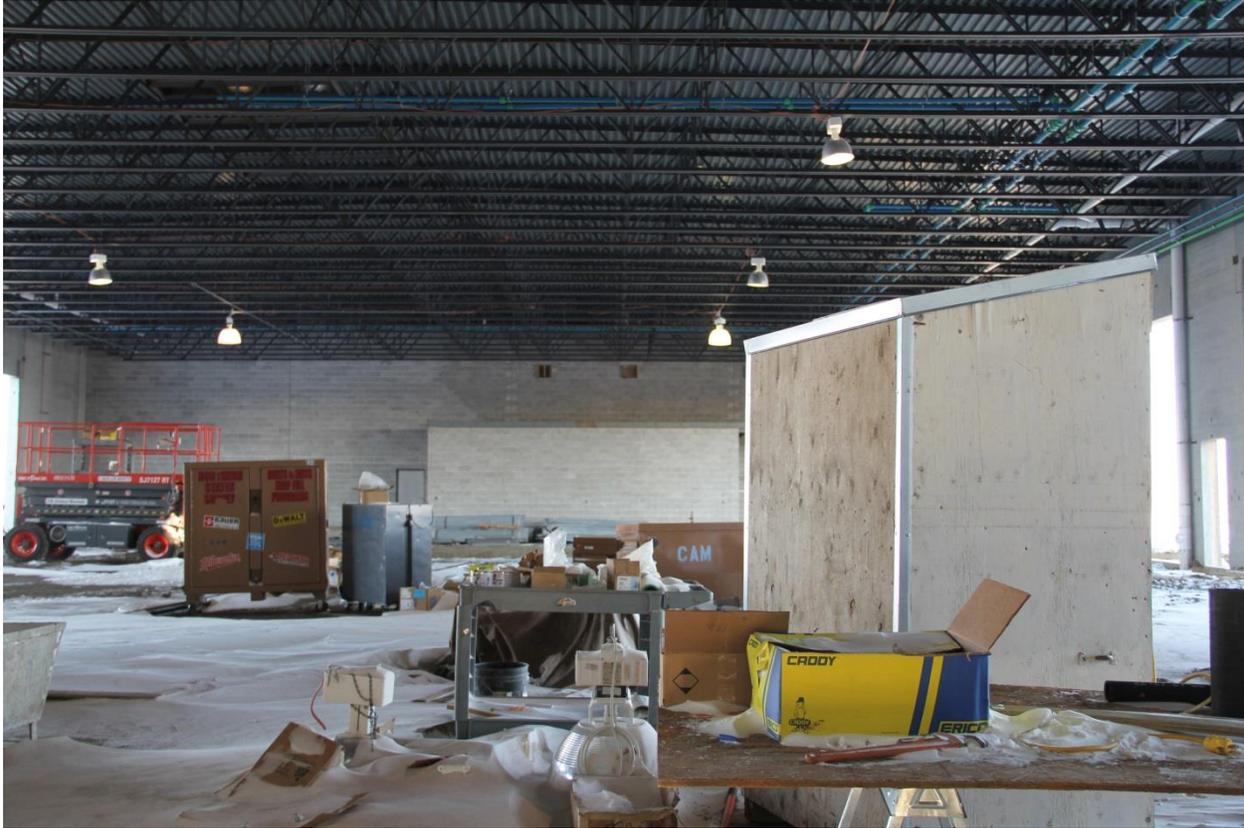
Photo 4: Area "A" looking back upon the wash bay.

3. Masonry work is completed in Area "A", temporary lights have been placed. The contractor plans to install garage doors in the next few weeks and begin to temper the space. The construction team plans to coordinate the fire suppression water storage tank to be sure it is on-site prior to the slab pour (*please see Photo 4*).
