Field Observation Report #20

Date: April 10, 2014
Time: 3:00 pm
Weather: Sunny
Temperature: 58 degrees
% Complete: 87% Visible
Trades: Framing, Masonry, Dirtwork
Crew Size: 10-12

Project: Burleigh County Shop
Project No: 12-04
Location: Bismarck, ND

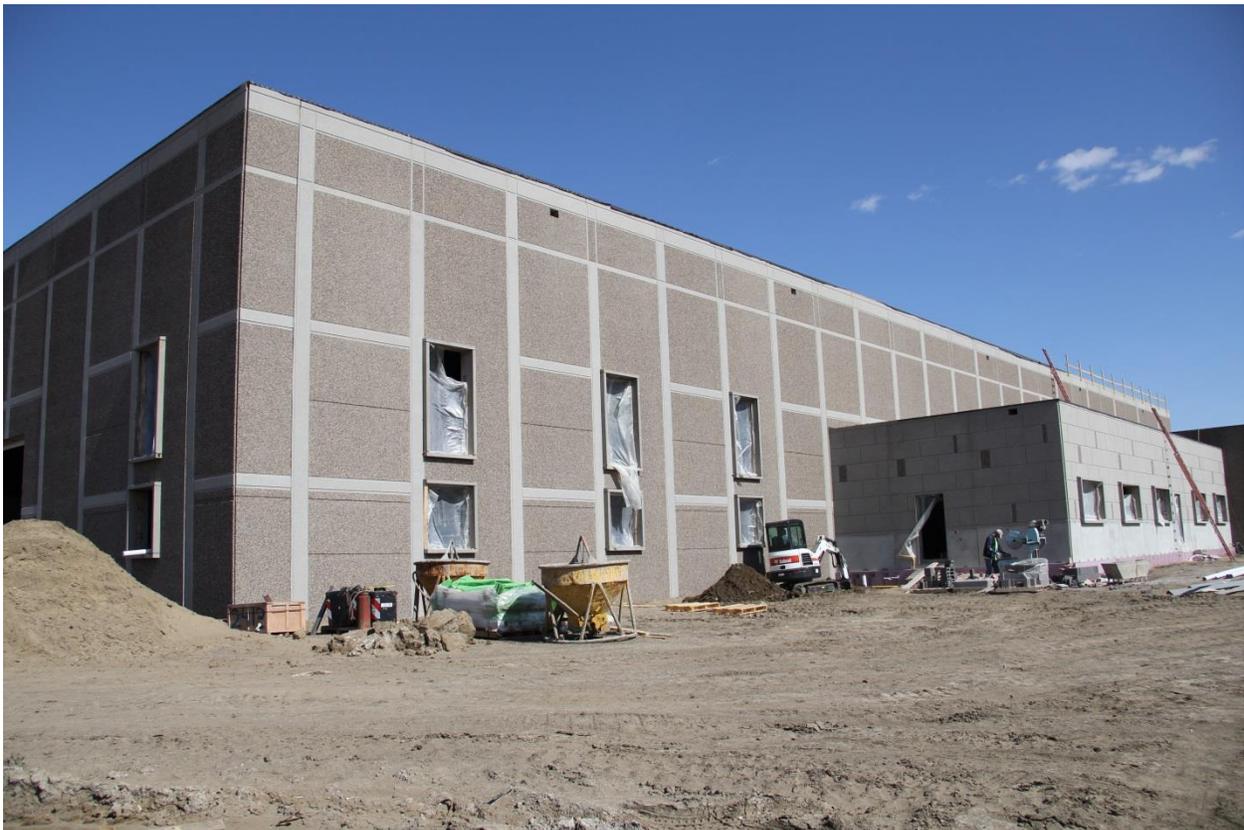
Photo 1: Window boxes have been placed

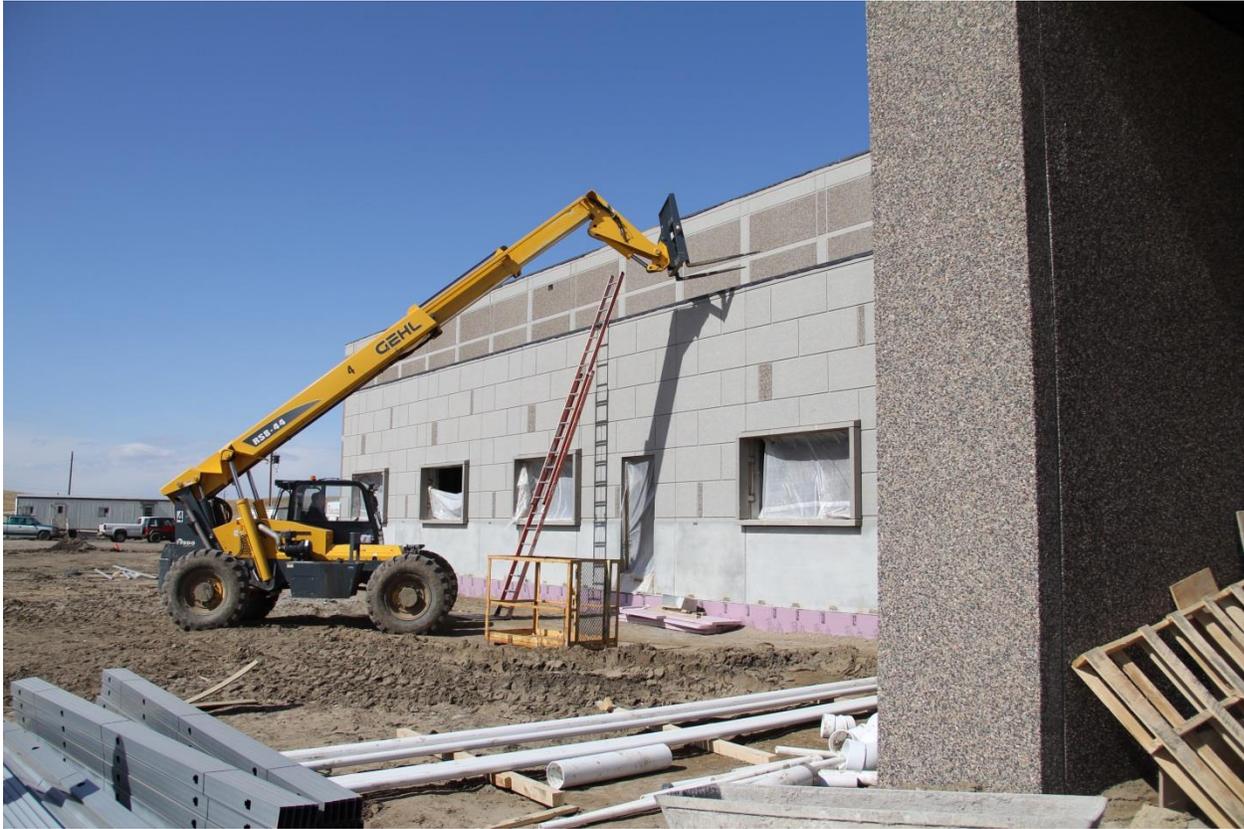
1. Roofing has been completed over the raised roof area and canopy. Only seventy feet remains over Area "B." This work is expected to be complete next week.
2. The electricians have initialized the electrical service work in areas where the roof has been placed. This work is expected to be completed in 4-6 weeks.

Photo 2: Roofing work continues, but is nearing completion.

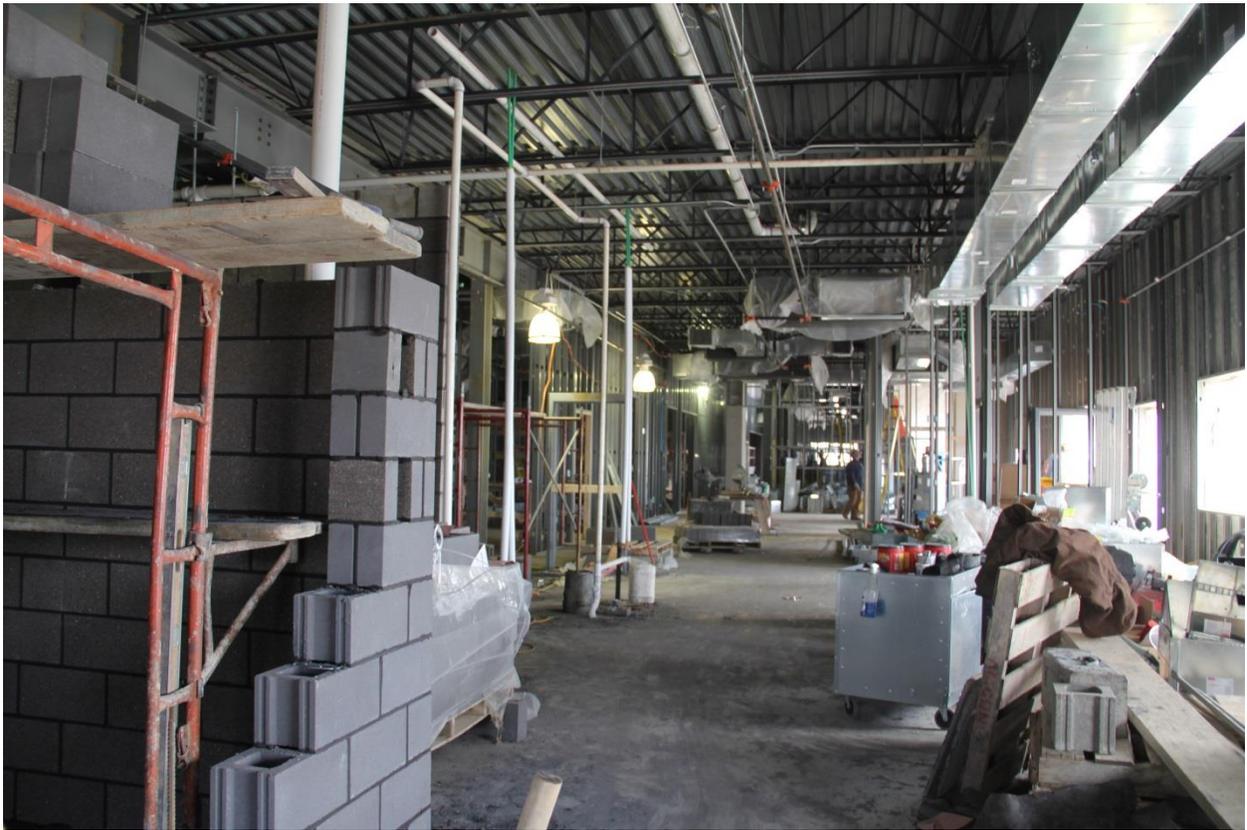
Photo 3: Roofing work continues, but is nearing completion.

6. Masonry work is underway in the locker rooms. The burnished finish is only required where exposed. Therefore any block above the ceiling or behind lockers can be standard block (*please see photo 3*).

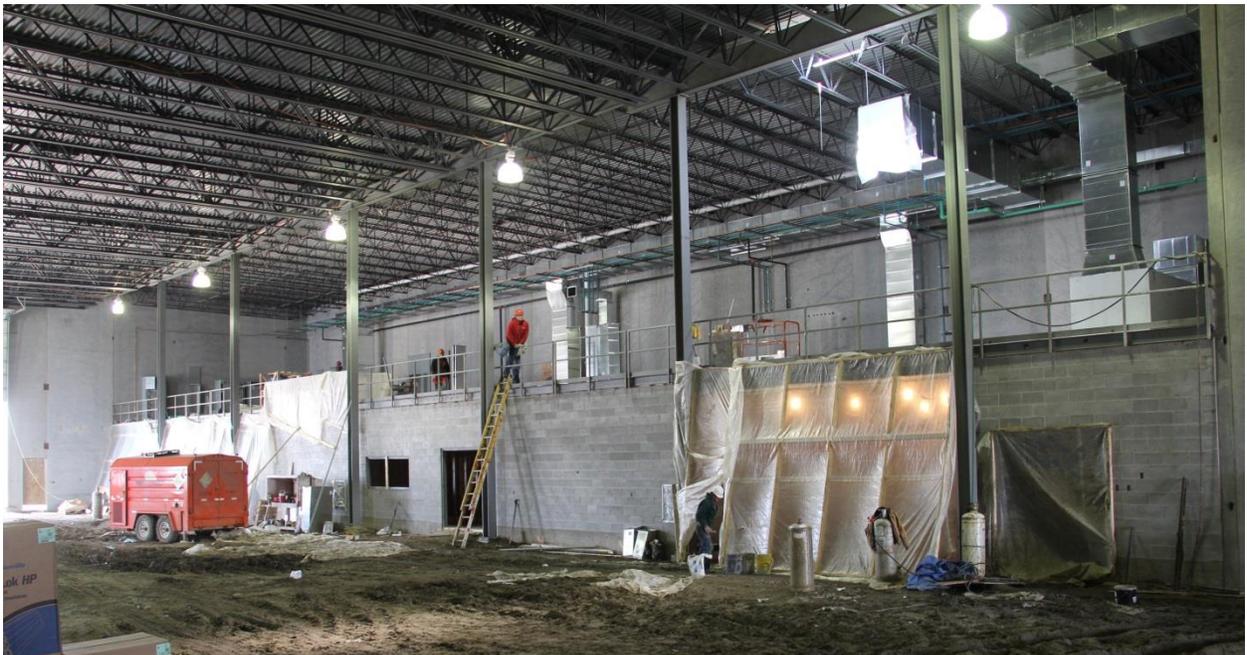
Photo 4: Mechanical and Electrical contractors are working on mezzanine slabs.

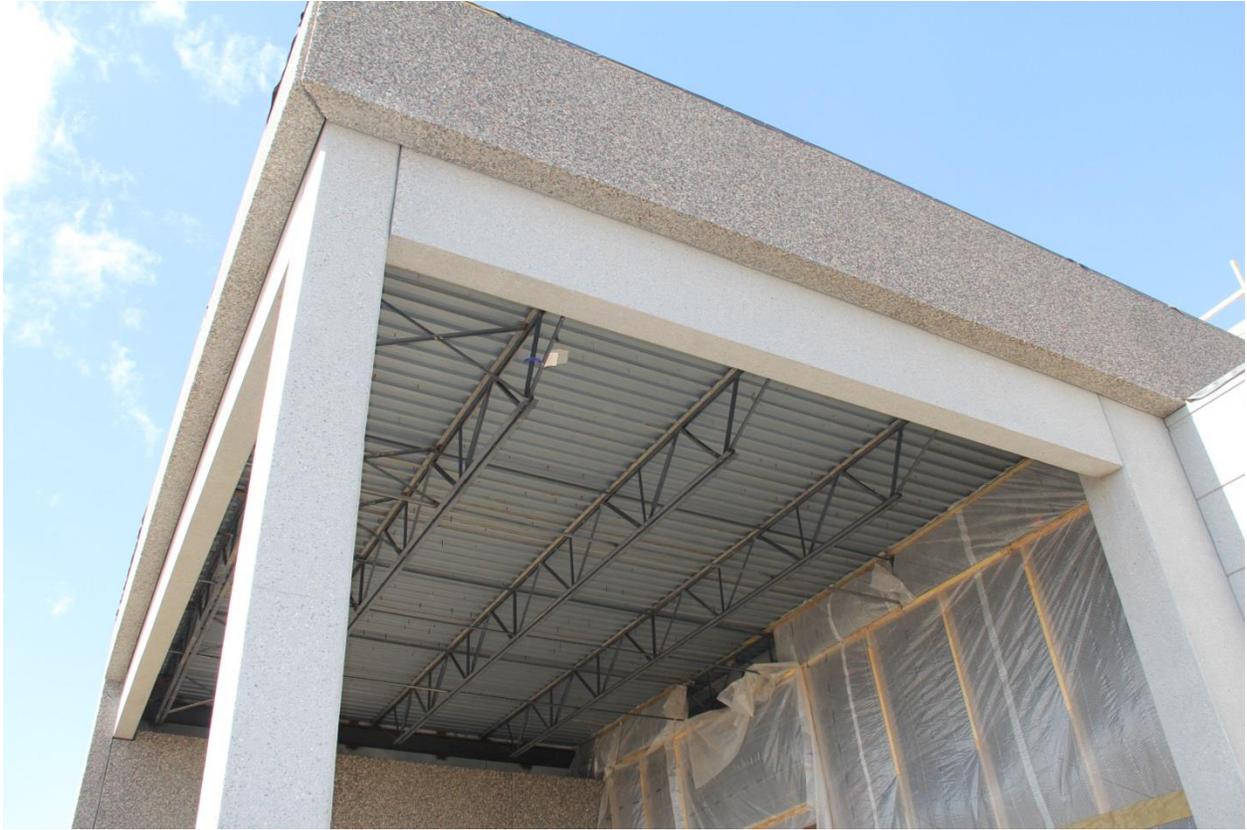
Photo 5: The canopy soffit framing is under discussion.

7. The structural engineer has provided additional options to replace the canopy framing design indicated on Drawings 1/A4.5, Drawing 10/S6.3 and Drawing 11/S6.3.
 - a. Please see the attached sketches from CW Structural for contractor options related to canopy framing. Also, the image above shows the area where this will potentially be incorporated.

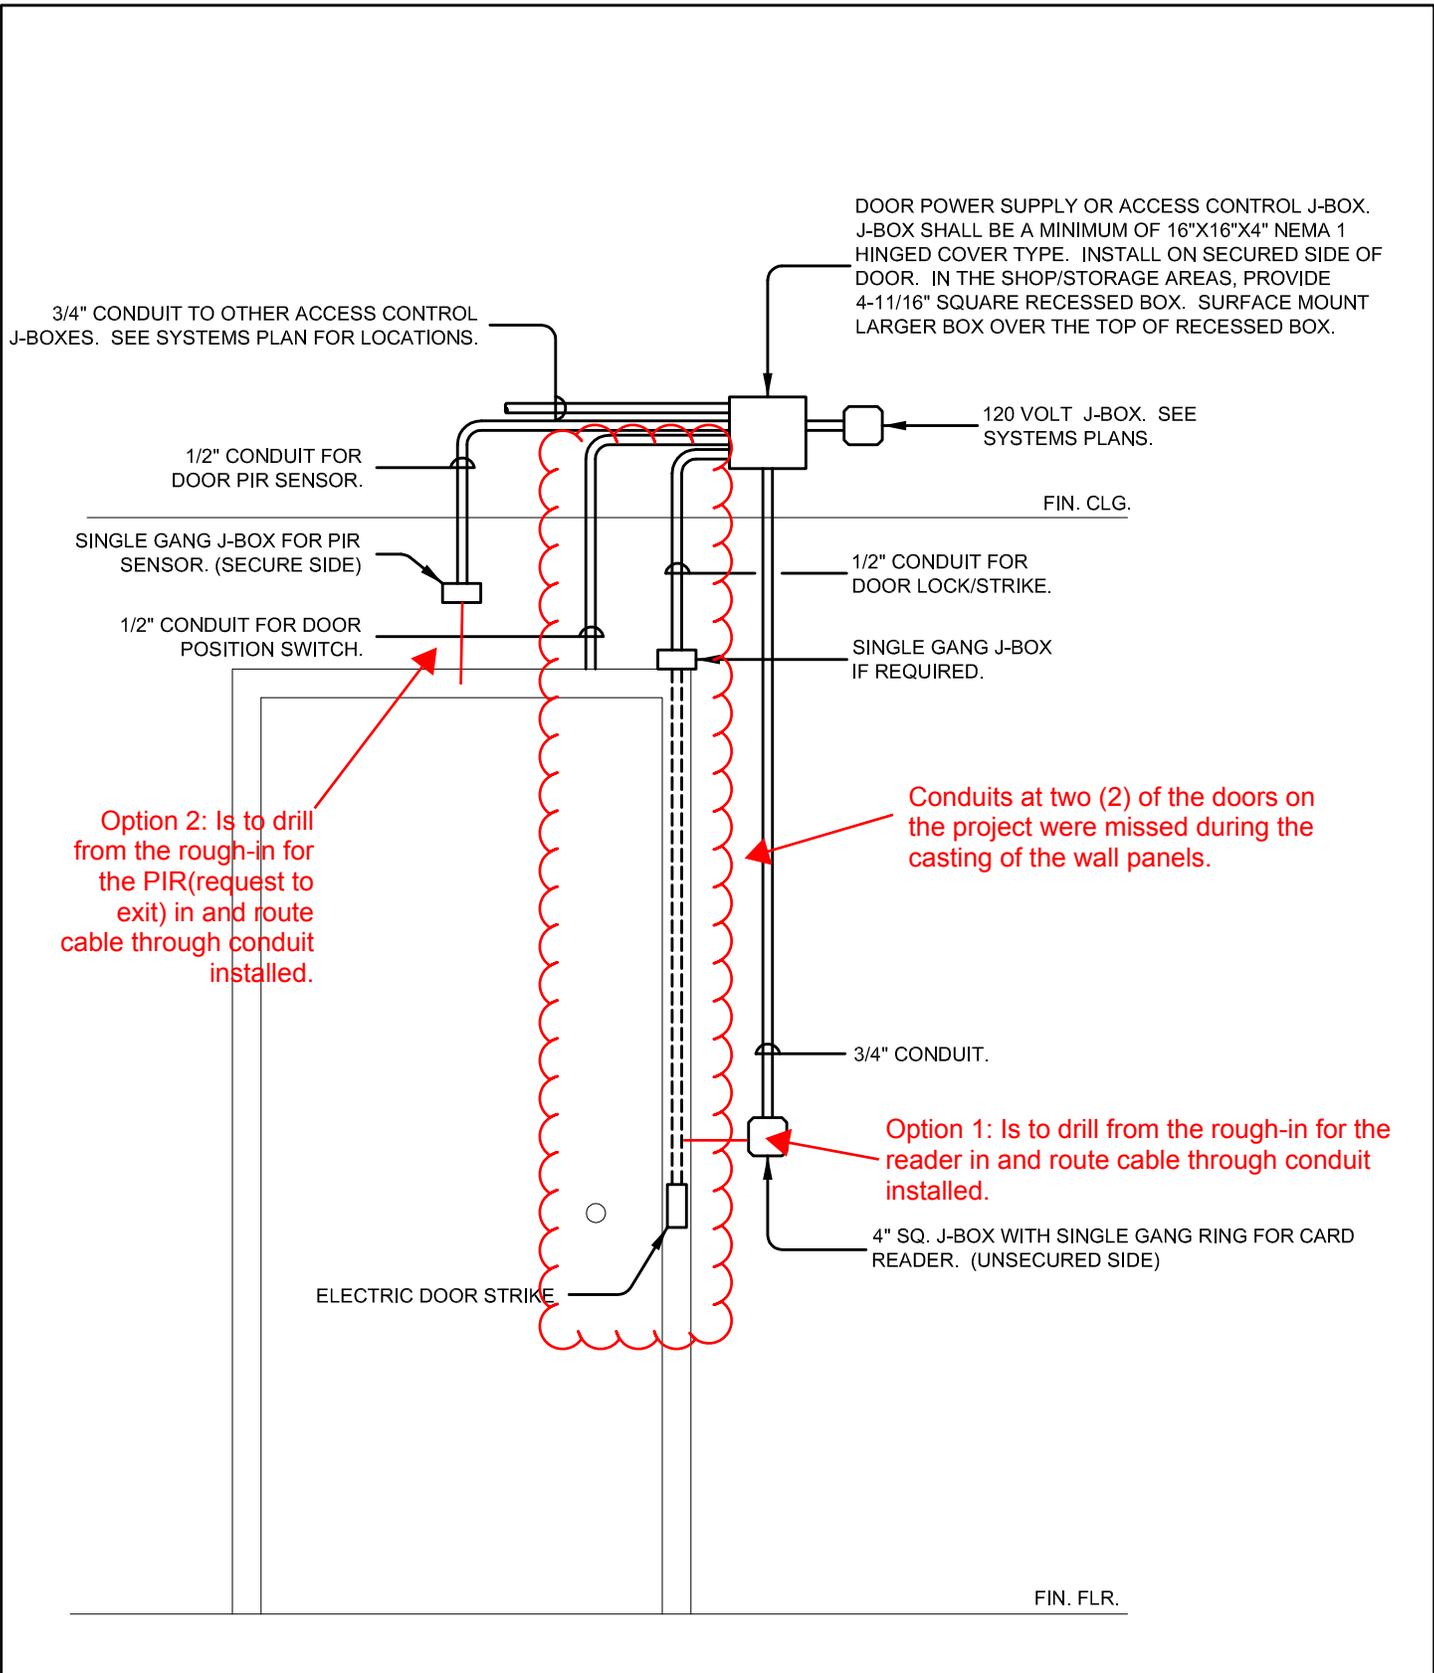
Burleigh County Highway Department
 Garage and Shop
 Detail 5/E4.5
 Access Control Door Rough-In

3. Some door frames that are set in the pre-cast walls require power that was not set in the panels. The electrical engineer, John Klein, indicated the following in response to this:

- a. "Regarding the missed conduits for the electric strike at the Burleigh County Shop. Talking with Scott at BEI, there are two (2) locations where Wells Concrete missed the conduits; one in the office area and one in the shop area. I put together the two options for getting the required conductors to the electric strike; in either case the fix is somewhat easy"

- b. Please see the attached drawing from Apex Engineering for information relating to these fixes.
4. There are concerns with the water service being frozen and the possibility of broken valves. This hasn't been confirmed yet and is awaiting the system to be completely thawed.
