Field Observation Report #21

Date:	<u>May 8, 2014</u>	Project:	<u>Burleigh County Shop</u>
Time:	<u>3:00 pm</u>	Project No:	<u>12-04</u>
Weather:	<u>Partly Cloudy</u>	Location:	<u>Bismarck, ND</u>
Temperature:	<u>58 degrees</u>		
% Complete:	<u>89% Visible</u>		
Trades:	<u>Drywall, Concrete, Taping</u>		
Crew Size:	<u>8-10</u>

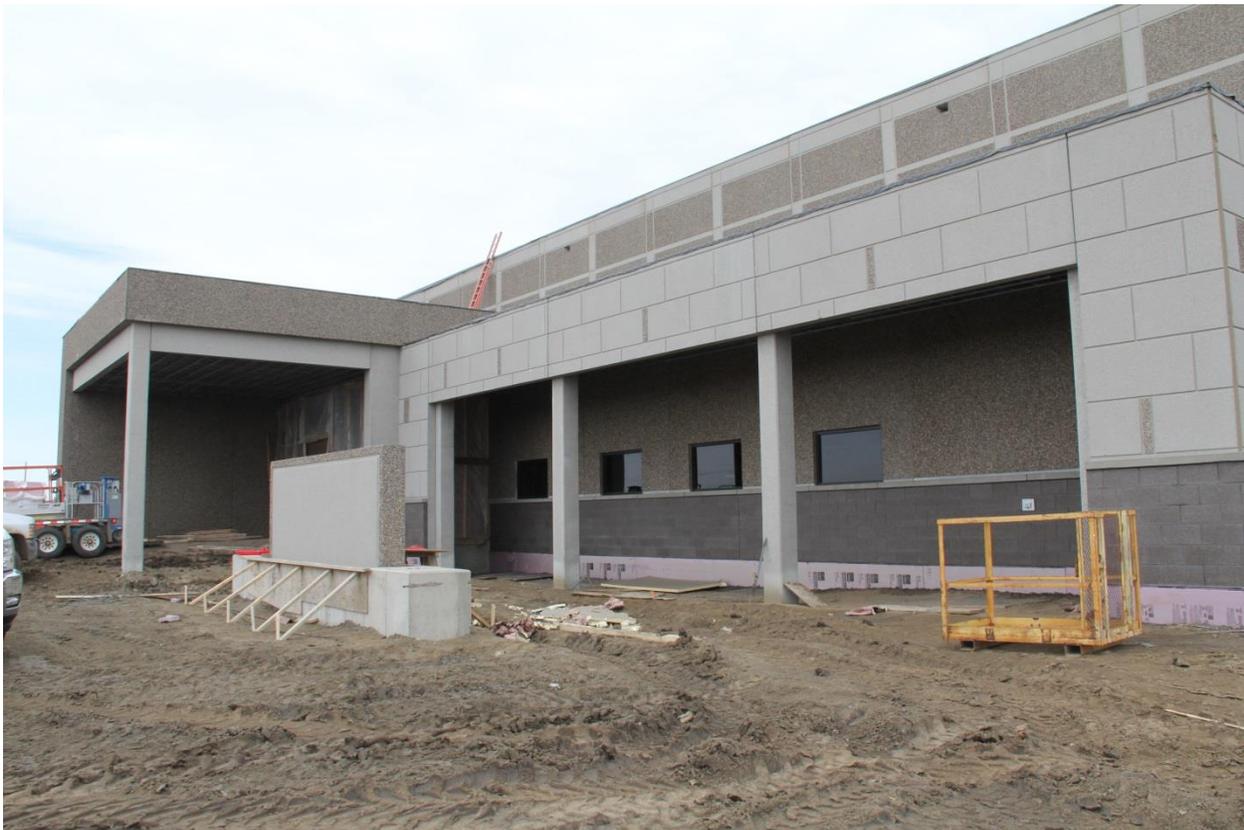
Photo 1: Exterior Burnished Block is complete; sign is placed.

1. The exterior burnished block wainscot is complete (see photo 1 & 3). Additional masonry work remains on the interior. The 4" masonry that was planned behind the eye wash station and drinking fountains in the shop area has been determined to be too thin to cover the plumbing lines, as they are currently installed. This block shall be increased to 6" or 8" CMU.

2. The pre-cast sign has been placed in-front of the building. The pre-cast panel is only finished on the front and side faces. The owner has directed the architect to proceed with sandblasting the back of the sign as well, to improve the appearance from the interior of the building.

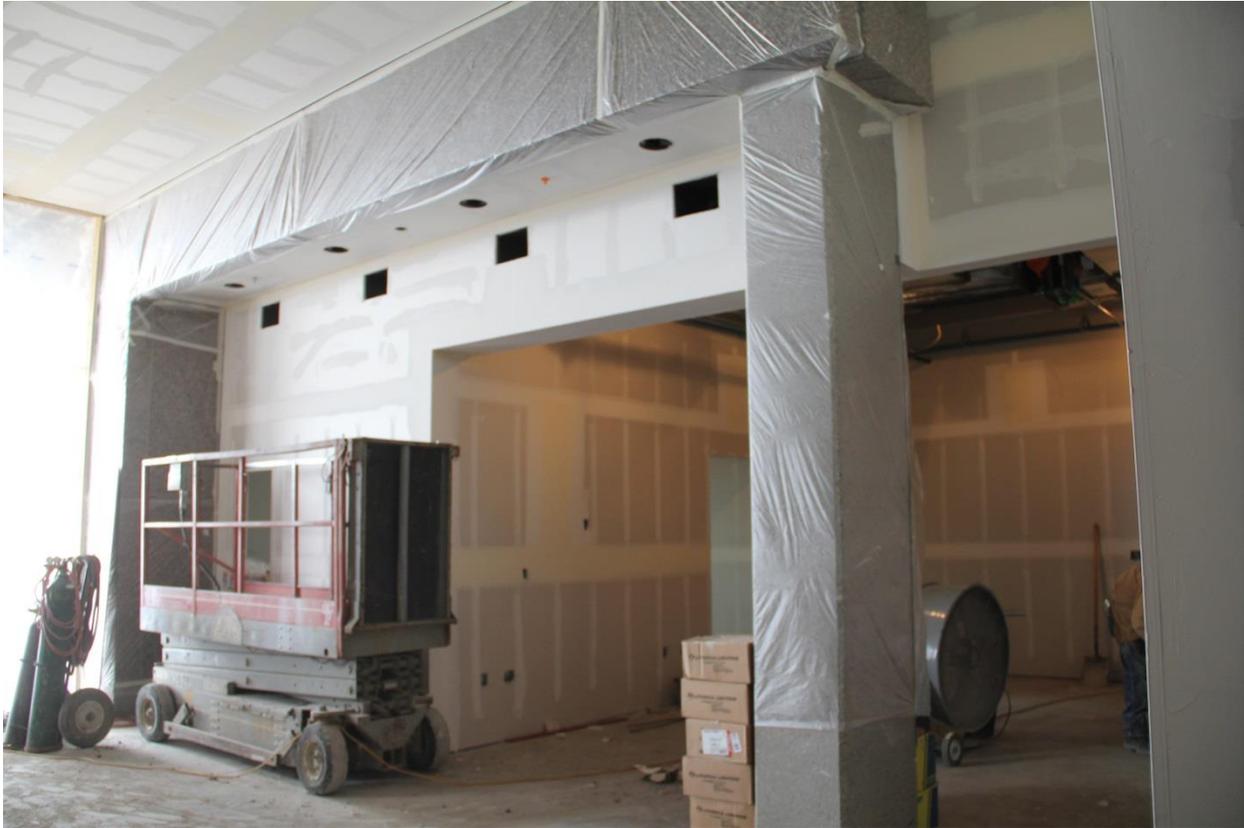
Photo 2: Reception Area exposed pre-cast is being protected through construction

3. The pre-cast concrete is being protected in the reception area from damage during construction. Drywall and taping continues in the administration area (*see photo 2*).

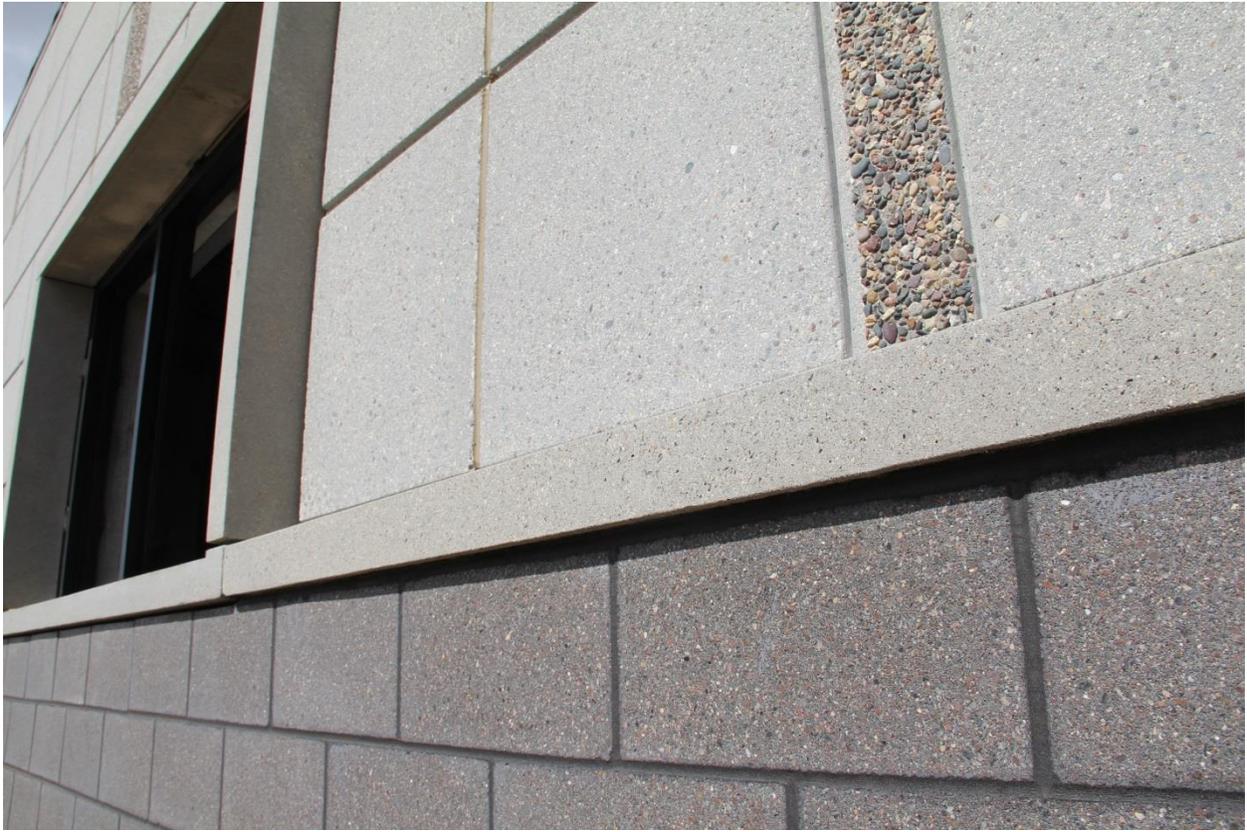
Photo 3: Close-up of burnished block and pre-cast at administration area exterior.

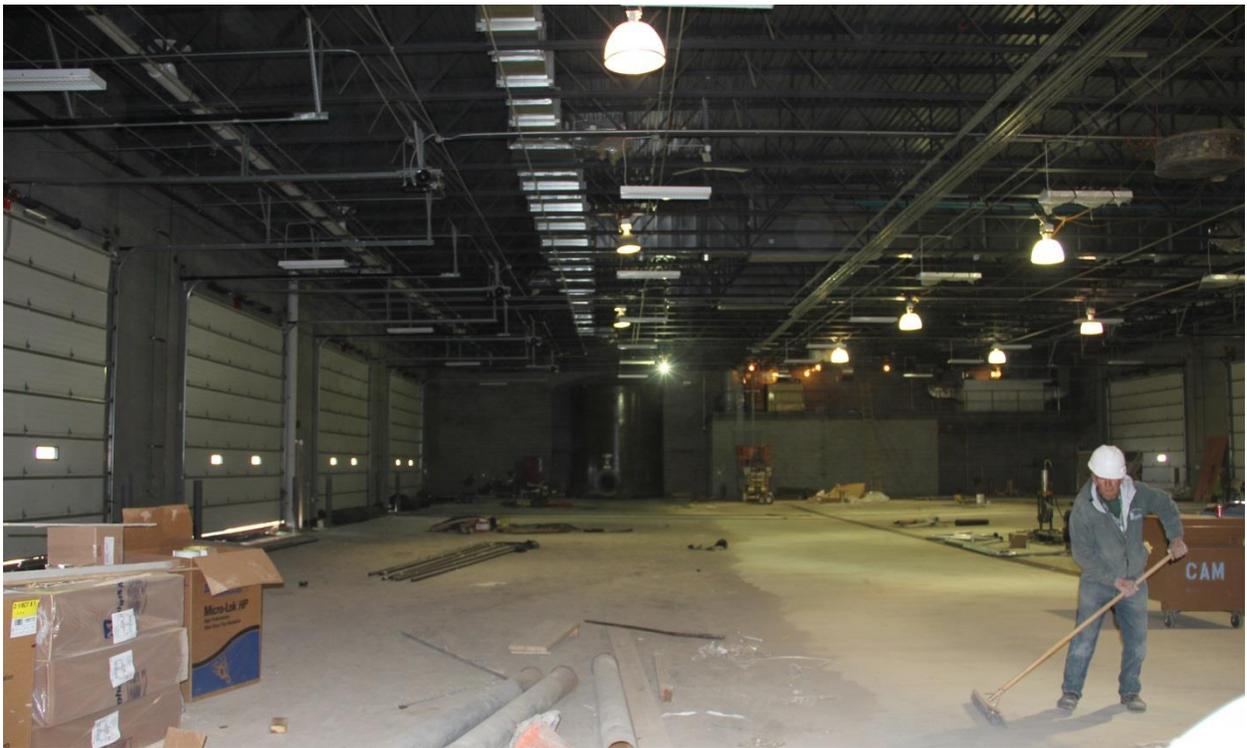
Photo 4: Area "A" – warm storage is nearing completion.
