## Field Observation Report #22

Date:	<u>May 22, 2014</u>	Project:	<u>Burleigh County Shop</u>
Time:	<u>3:00 pm</u>	Project No:	<u>12-04</u>
Weather:	<u>Partly Cloudy</u>	Location:	<u>Bismarck, ND</u>
Temperature:	<u>65 degrees</u>		
% Complete:	<u>92% Visible</u>		
Trades:	<u>Concrete, Painting</u>		
Crew Size:	<u>8-10</u>

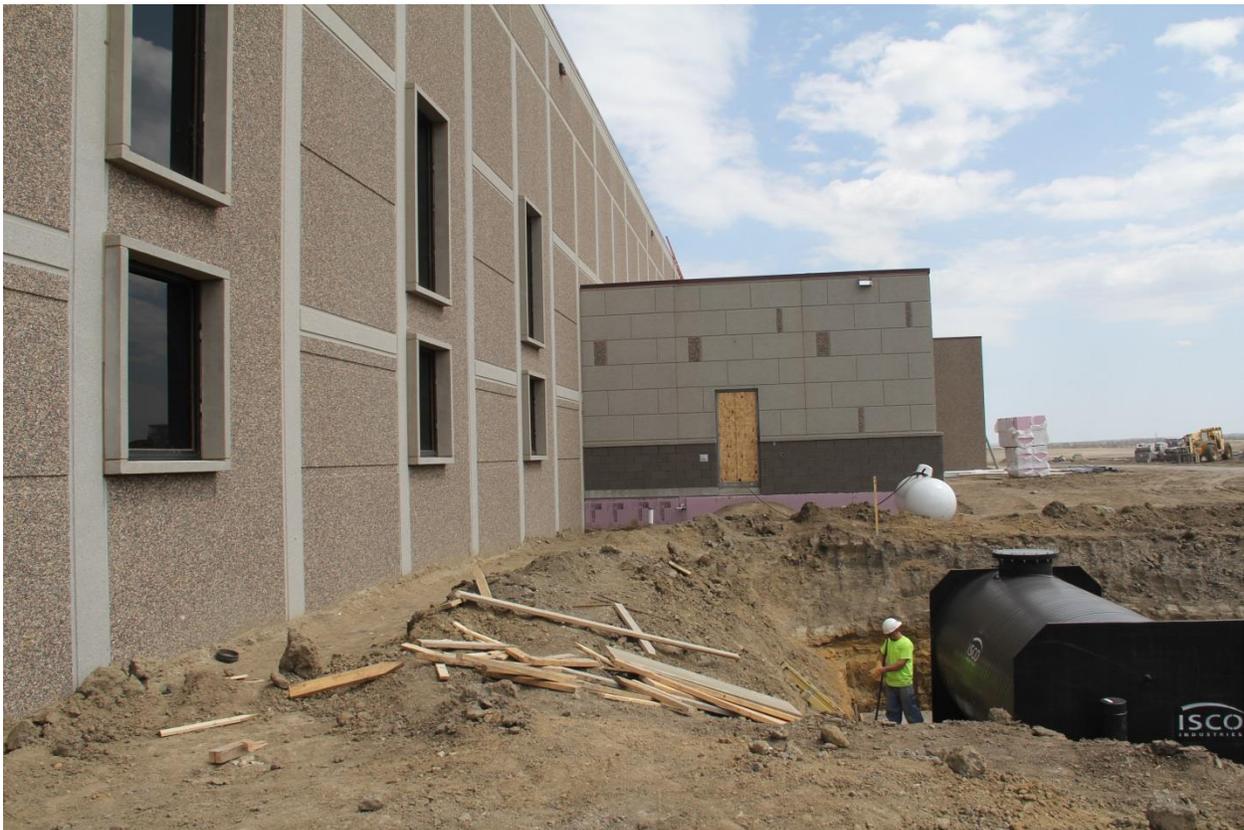
*Photo 1: Geothermal Valve Vault has been placed (black tank shown above)*

1. The geothermal valve vault has been placed. The mechanical contractor is asked to flag off areas for the owner to avoid, related to the geothermal wells, as they do site work around the building (*please see photo 1*). The mechanical contractor is also asked to locate the gas pumps to help coordinate owner and contractor work around the building.

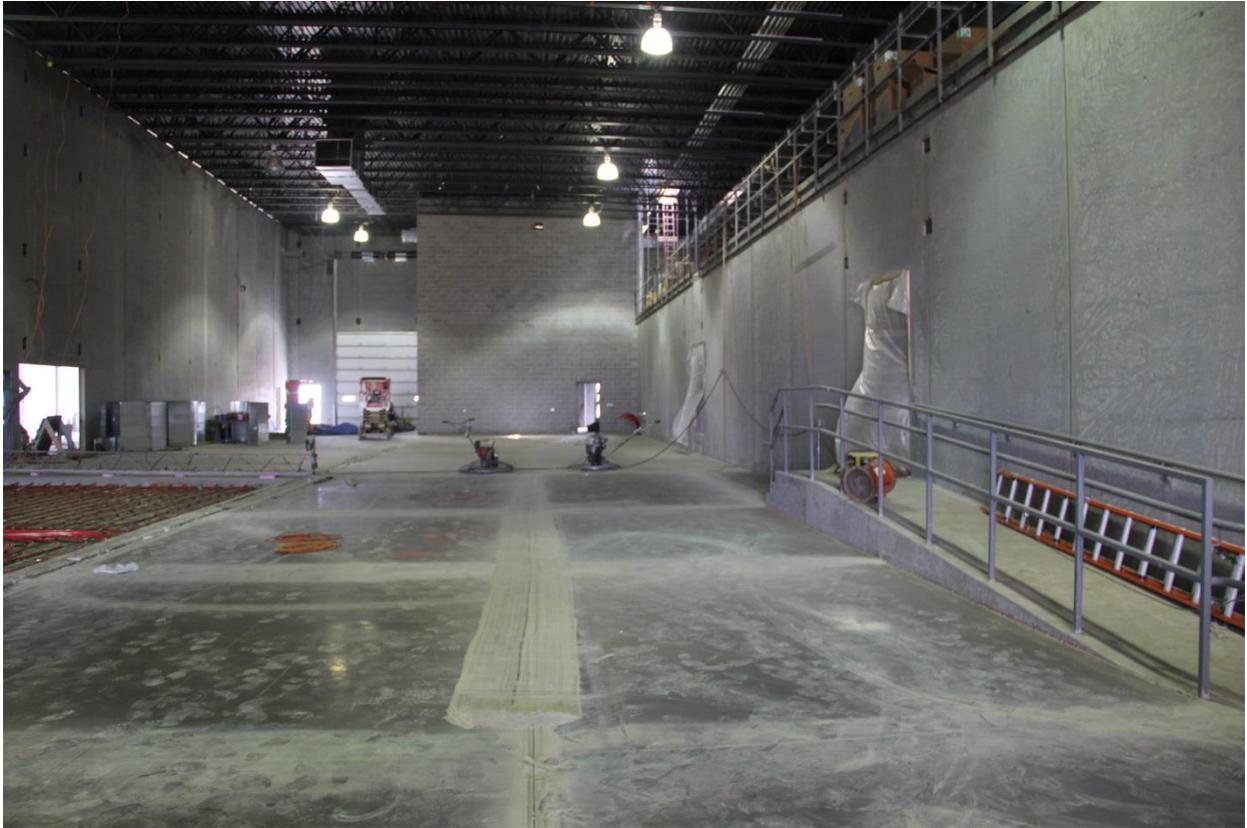
*Photo 2: Slab construction continues in the Maintenance Area.*

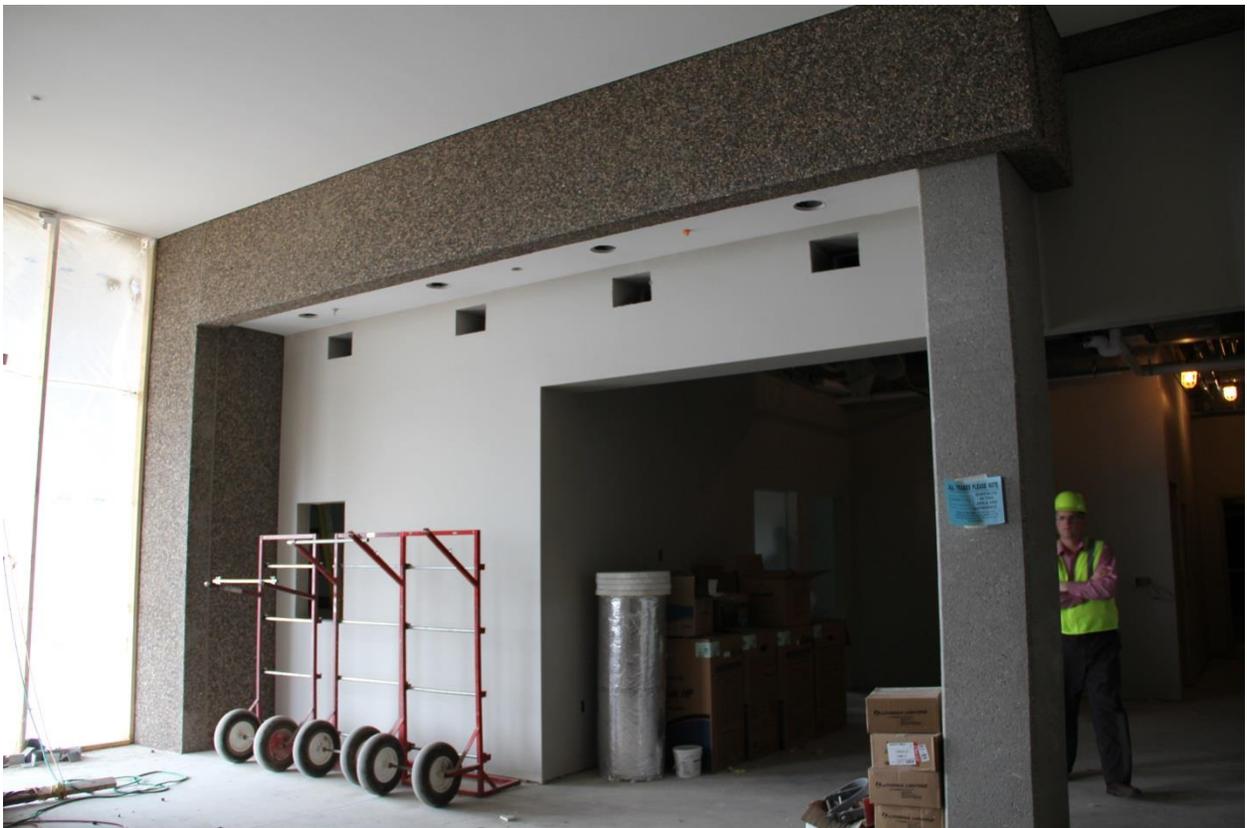
*Photo 3: Reception Area pre-cast*
