## Field Observation Report #23

Date: July 2, 2014  
Time: 3:00 pm  
Weather: Partly Cloudy  
Temperature: 70 degrees  
% Complete: 90% Visible  
Trades: Windows, Mech, Elect,  
Crew Size: 8-10

Project: Burleigh County Shop  
Project No: 12-04  
Location: Bismarck, ND

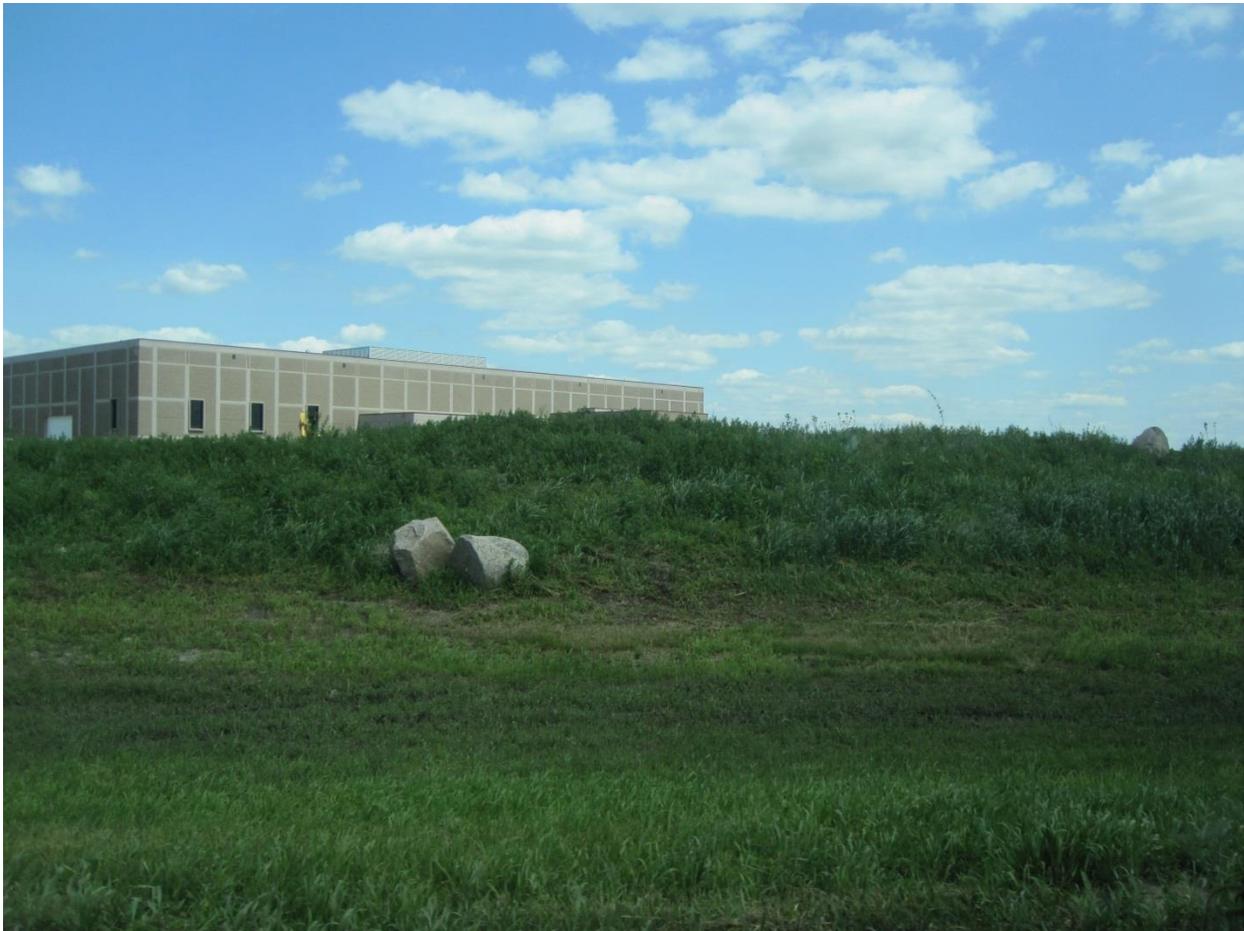
*Photo 1: View from the road*

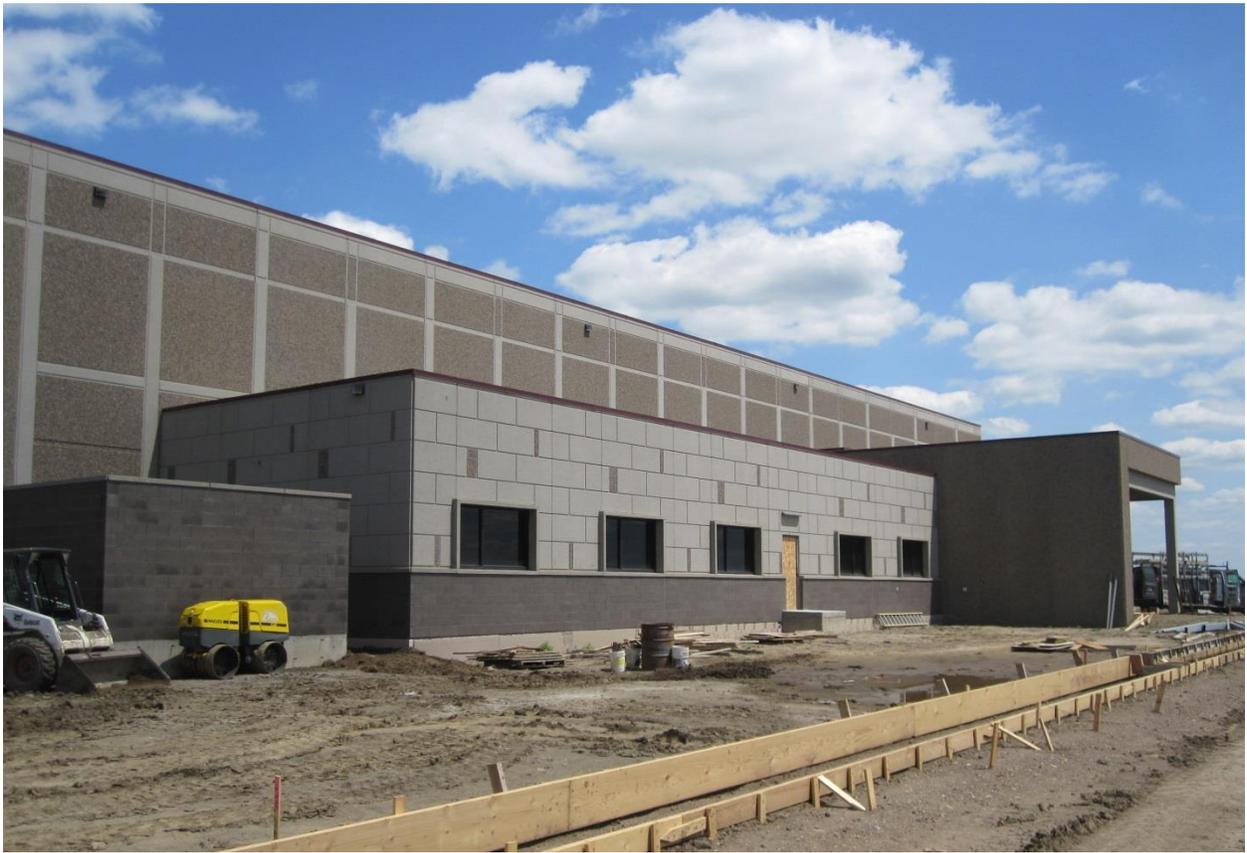
*Photo 2: The curb is being poured this week.*

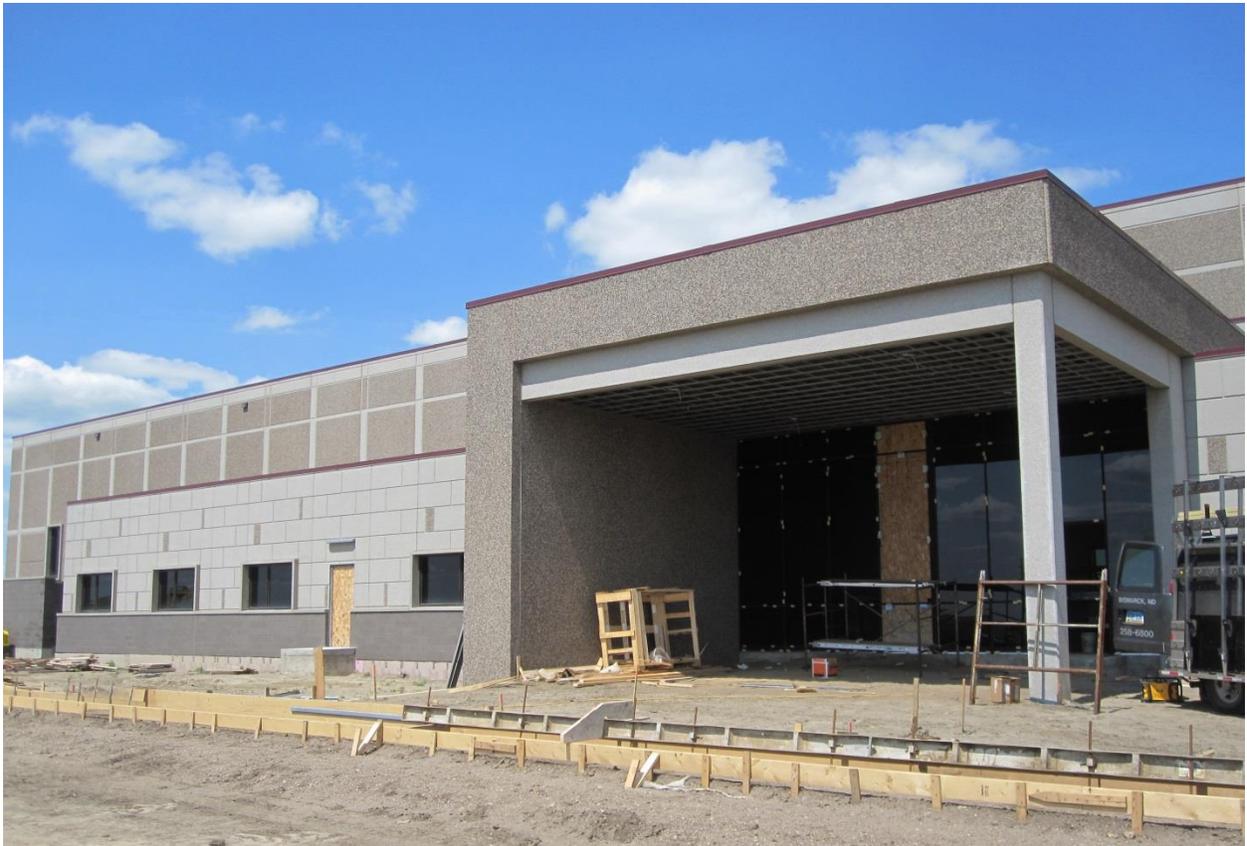
*Photo 3: the entry curtain wall windows are under construction*

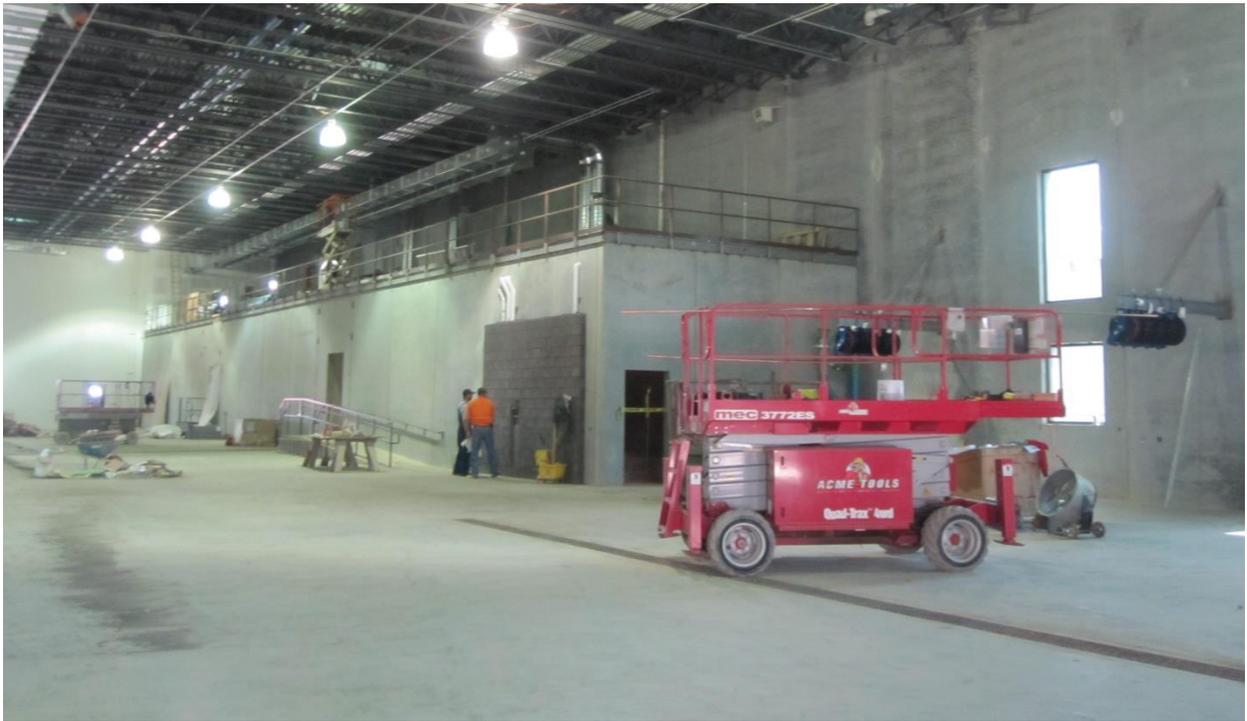
*Photo 4: Hose Reels and other equipment is being placed*

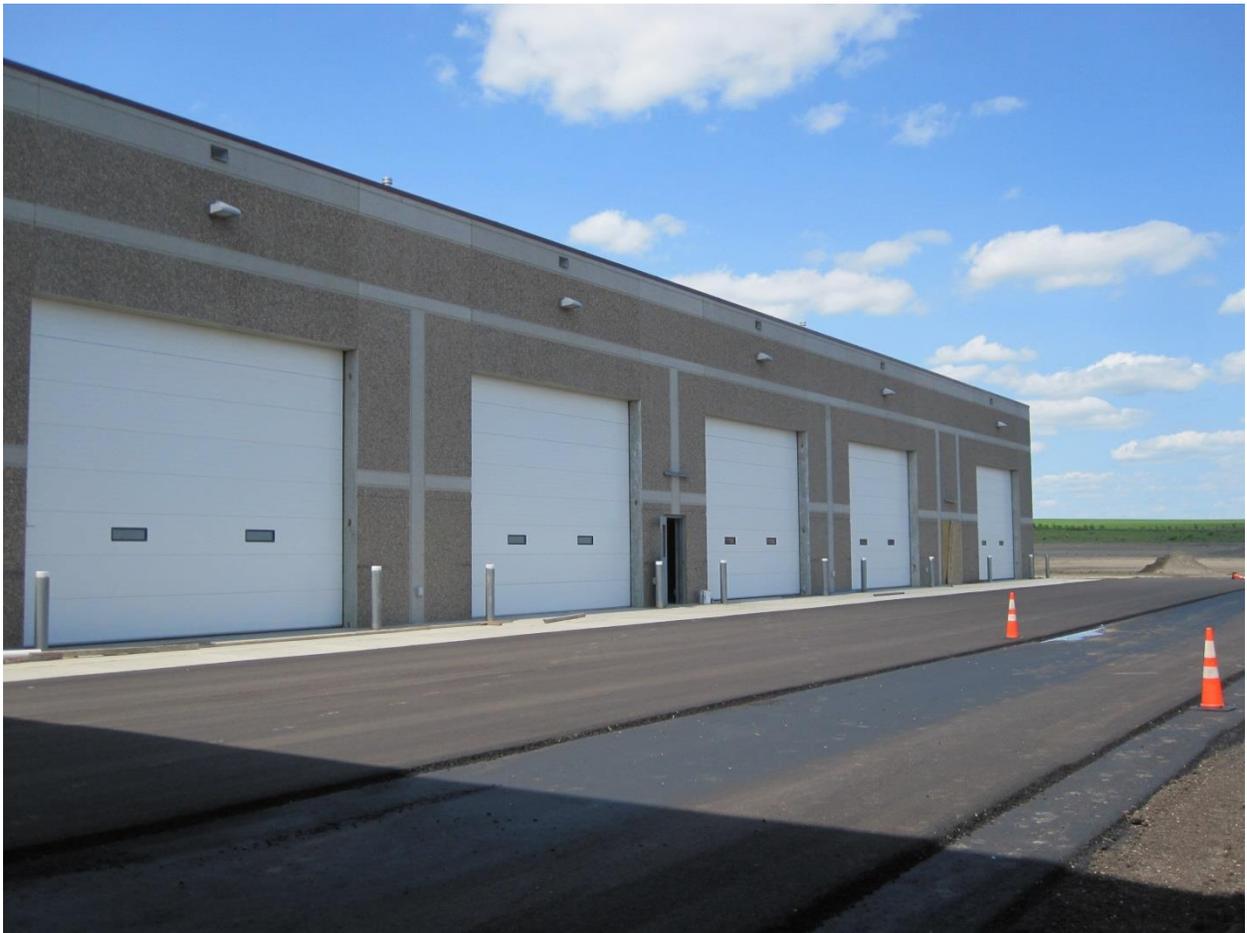
*Photo 5: The owner work in Phase 1 is underway.*

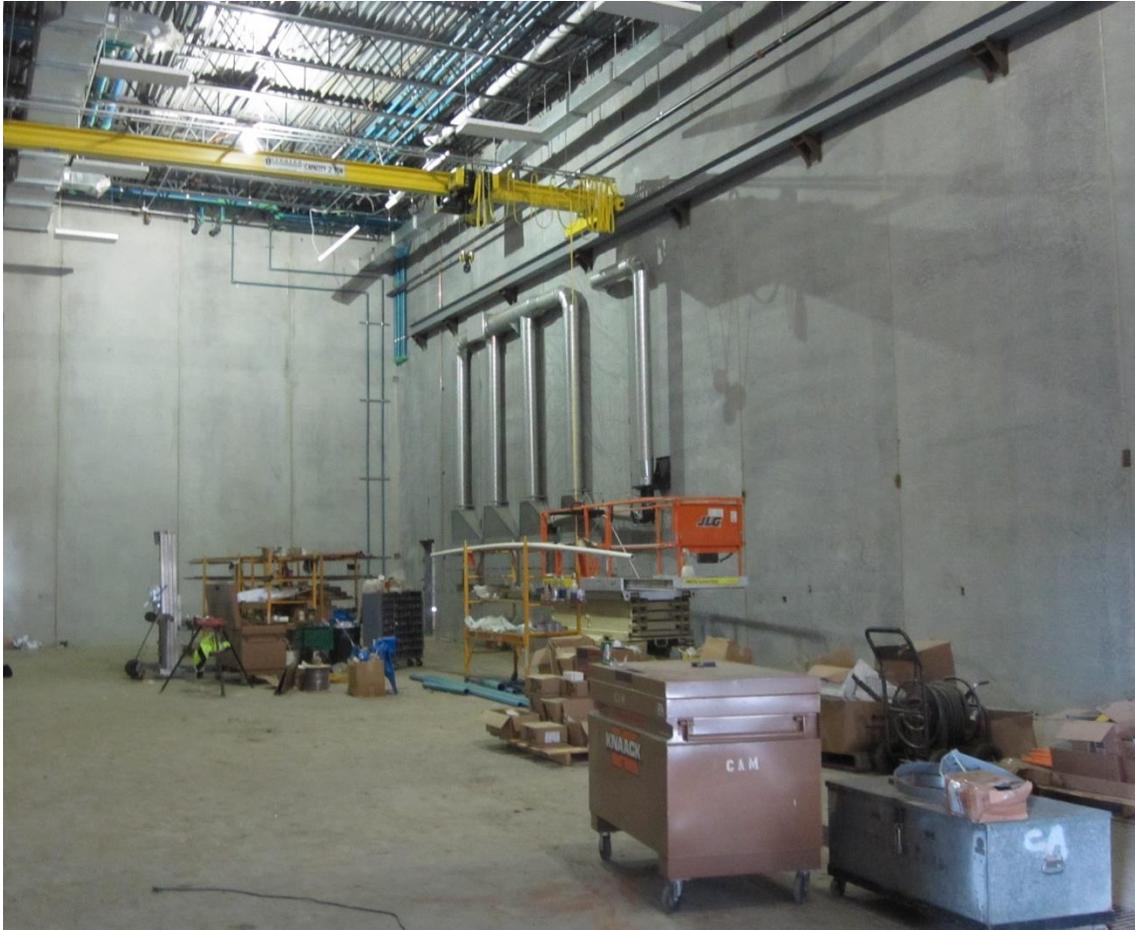
Photo 6: A view of the welding bay.
