Field Observation Report #24

Project: Burleigh County Shop
Project No: 12-04
Location: Bismarck, ND

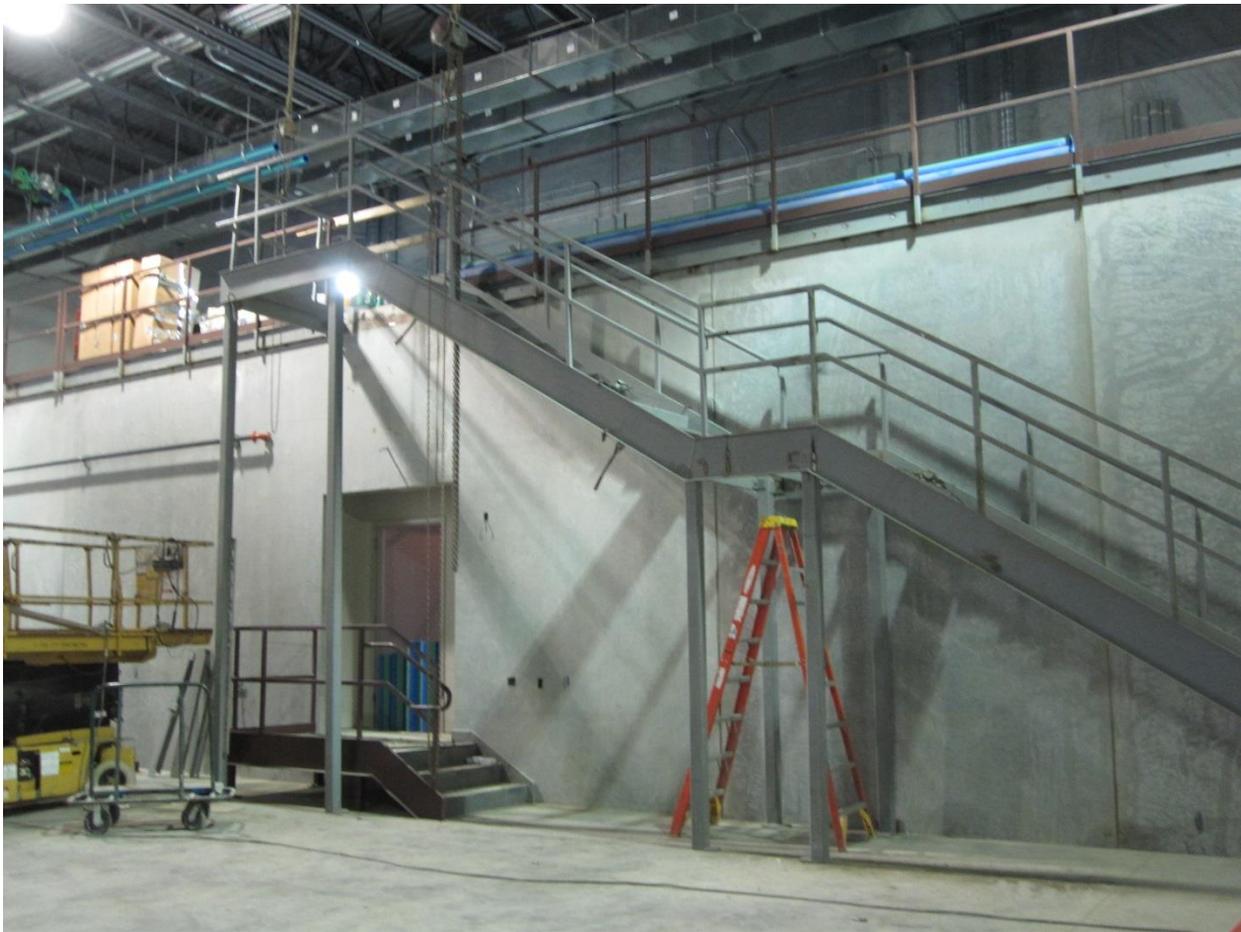
Photo 1: Stair Installation providing mezzanine access from main floor.

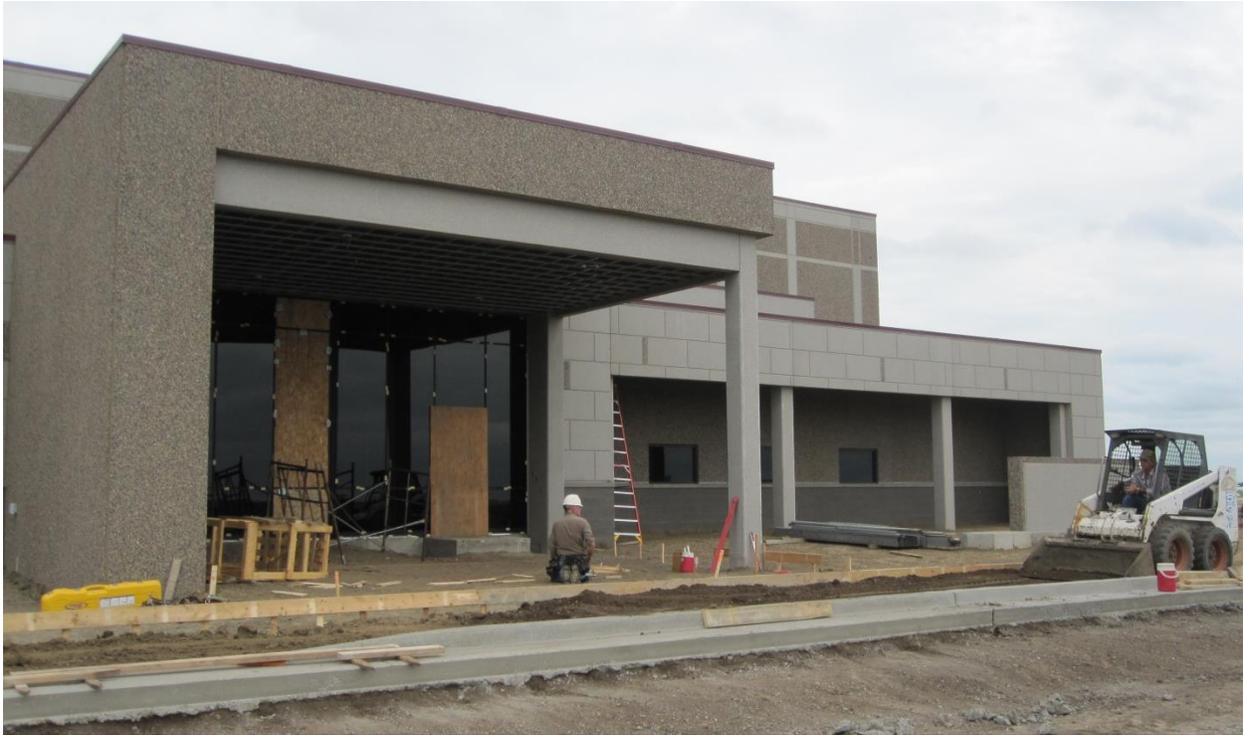
Photo 2: Curb and Gutter has been poured along the front of the building/ CW installation is underway

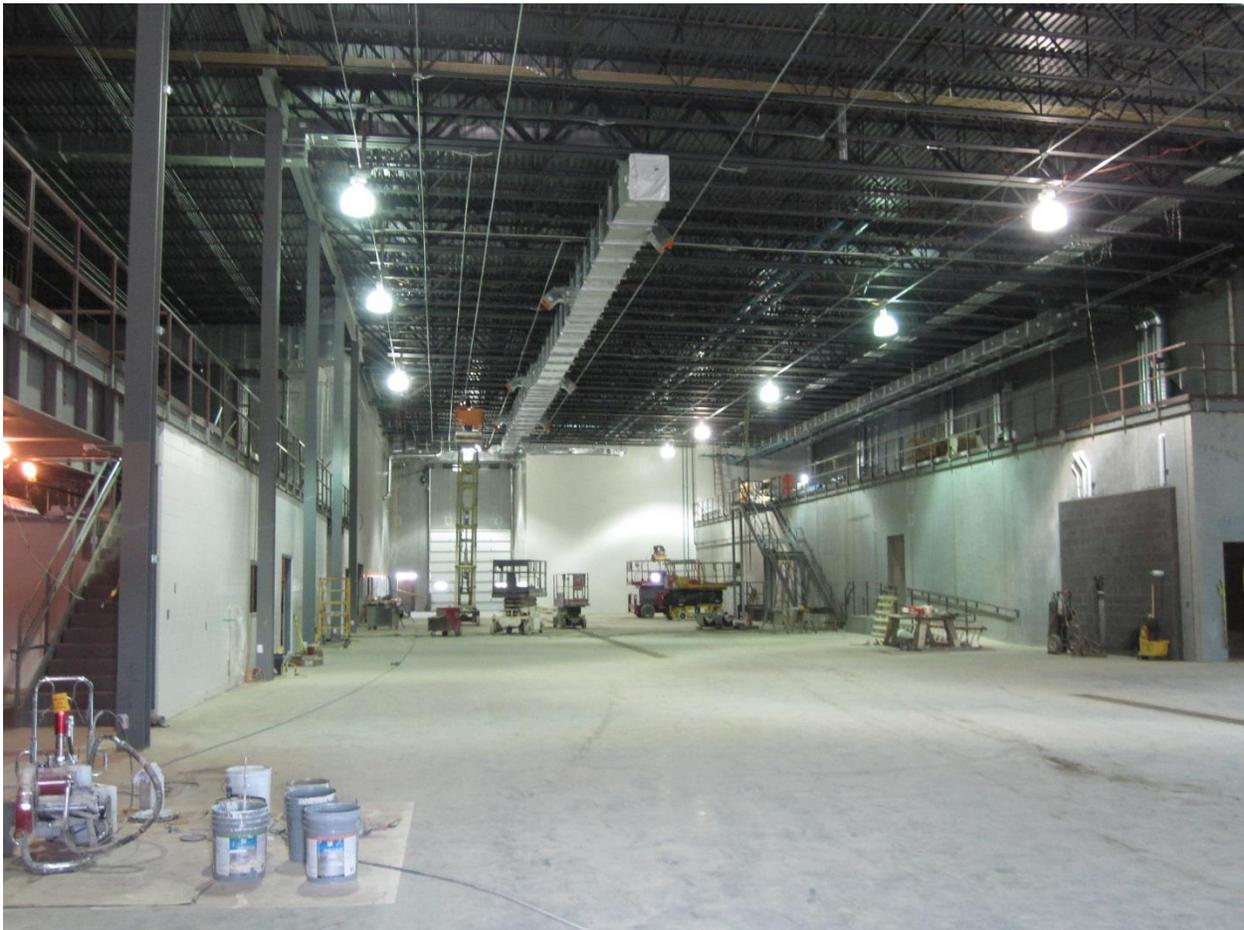
Photo 3: Painting continues in the shop area.

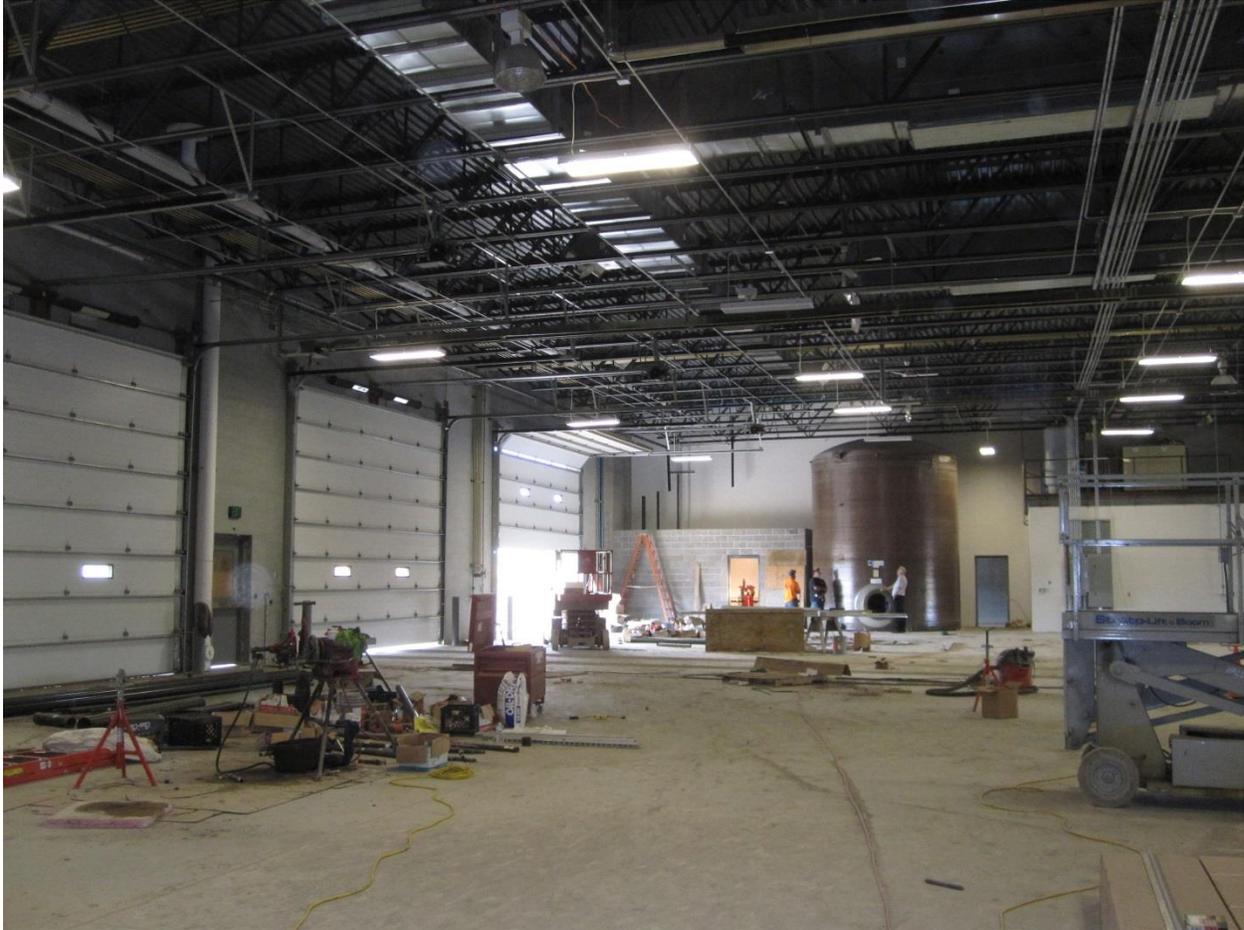
Photo 4: Hose Reels and other equipment is being placed
