Field Observation Report #27

Date:	<u>Sept 25th / Oct 2nd, 2014</u>	Project:	<u>Burleigh County Shop</u>
Time:	<u>2:00 pm</u>	Project No:	<u>12-04</u>
Weather:	<u>Variable</u>	Location:	<u>Bismarck, ND</u>
Temperature:	<u>60 degrees</u>		
% Complete:	<u>99% Visible</u>		
Trades:	<u>Finishes</u>		
Crew Size:	<u>5-7</u>

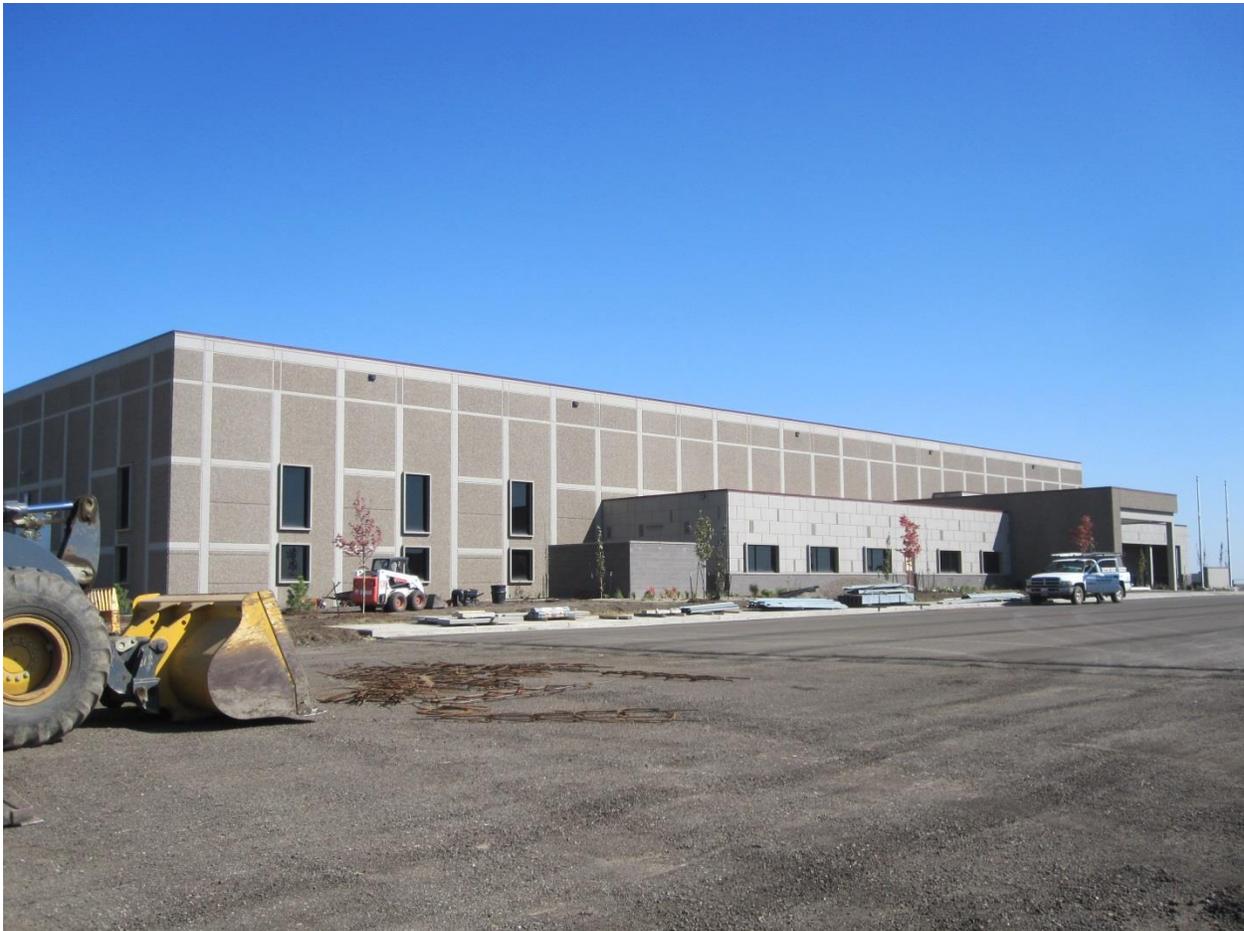
Photo 1: View from southwest side of the parking lot.

1. Landscaping work has begun, concrete floor sealing & hardening is underway, hardware is being installed, as well as plumbing fixtures. Project is wrapping up.

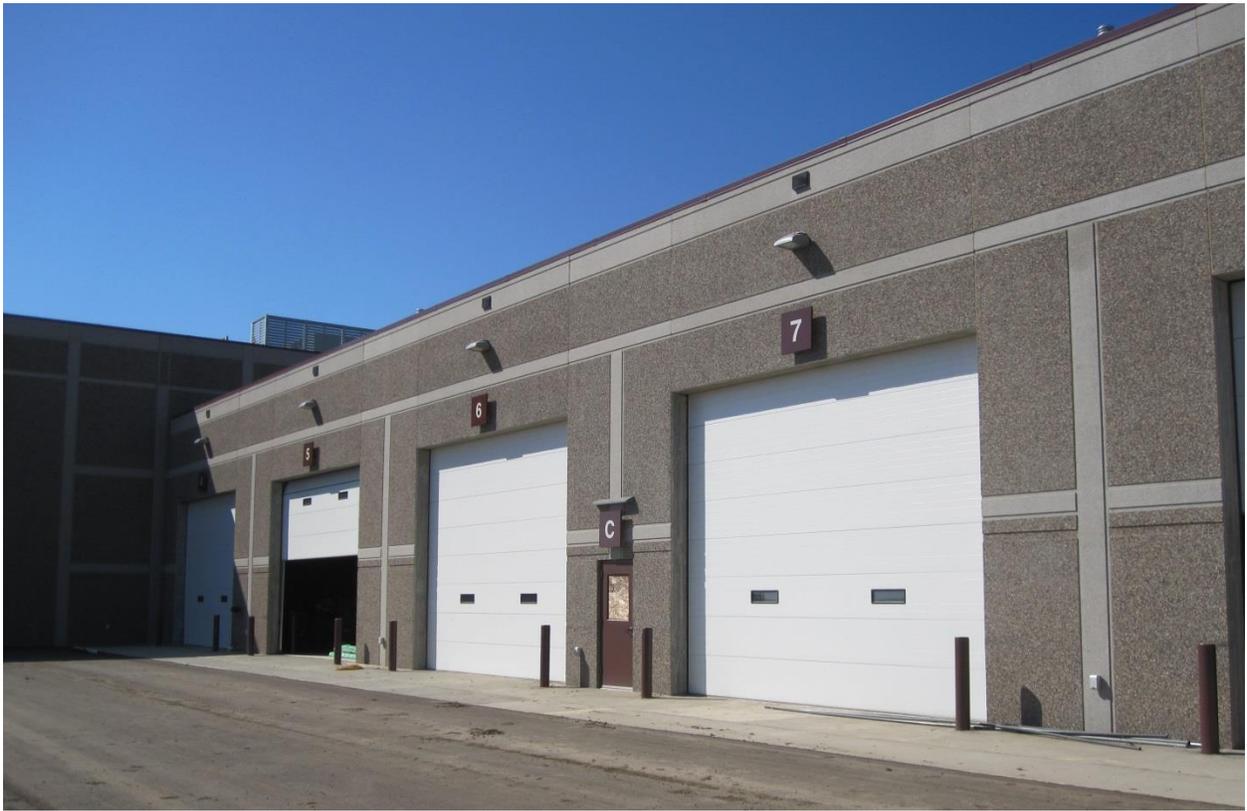
Photo 2: Exterior Signage has been installed.

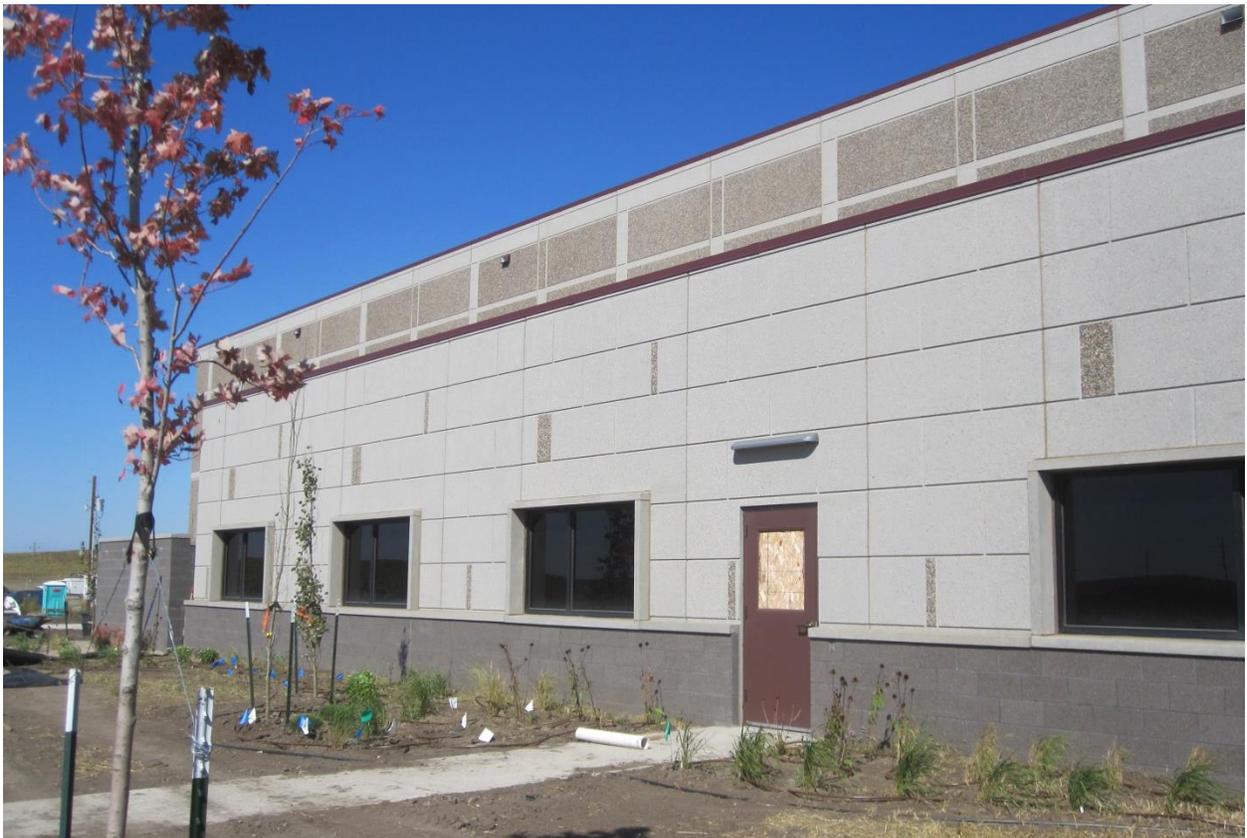
Photo 3: Landscaping is underway.

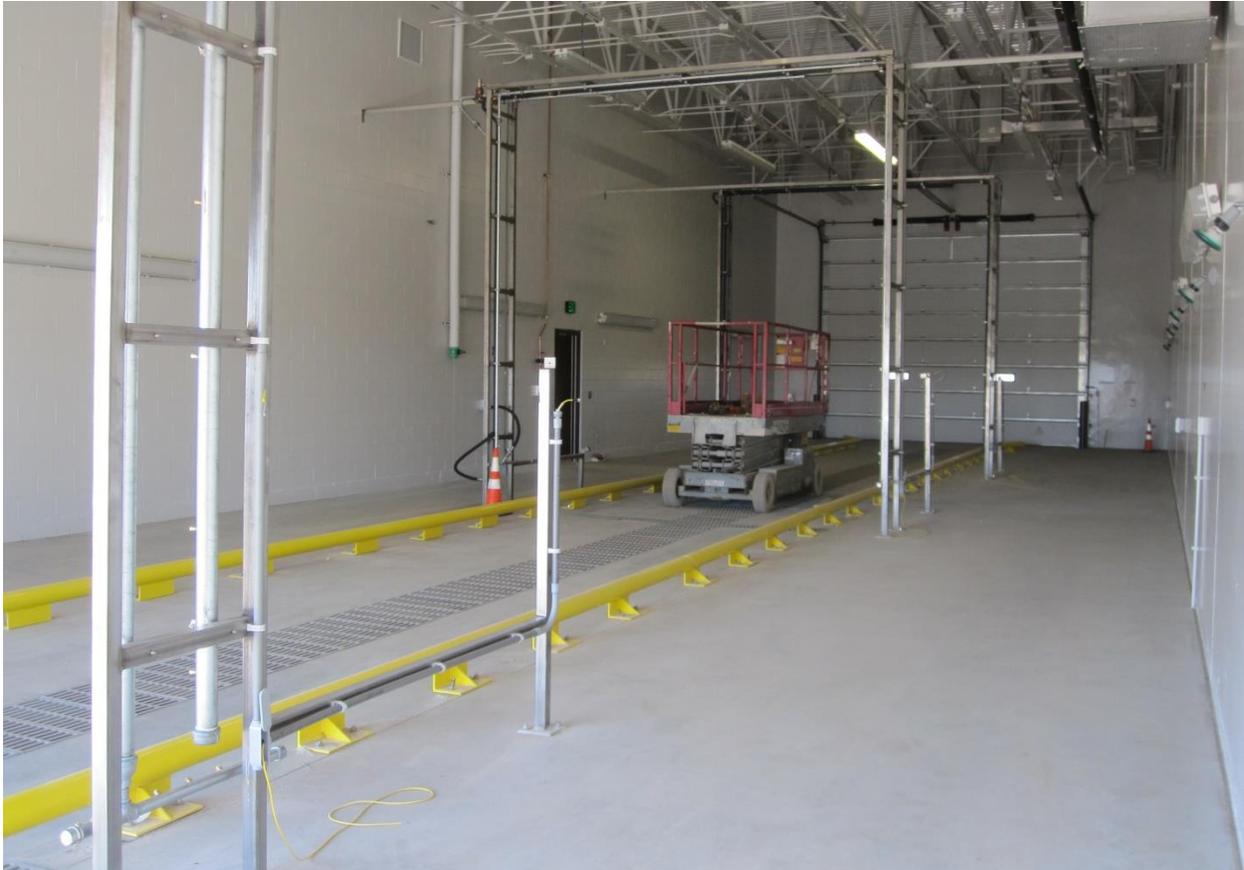
Photo 4: A view of the Automatic Truck Wash

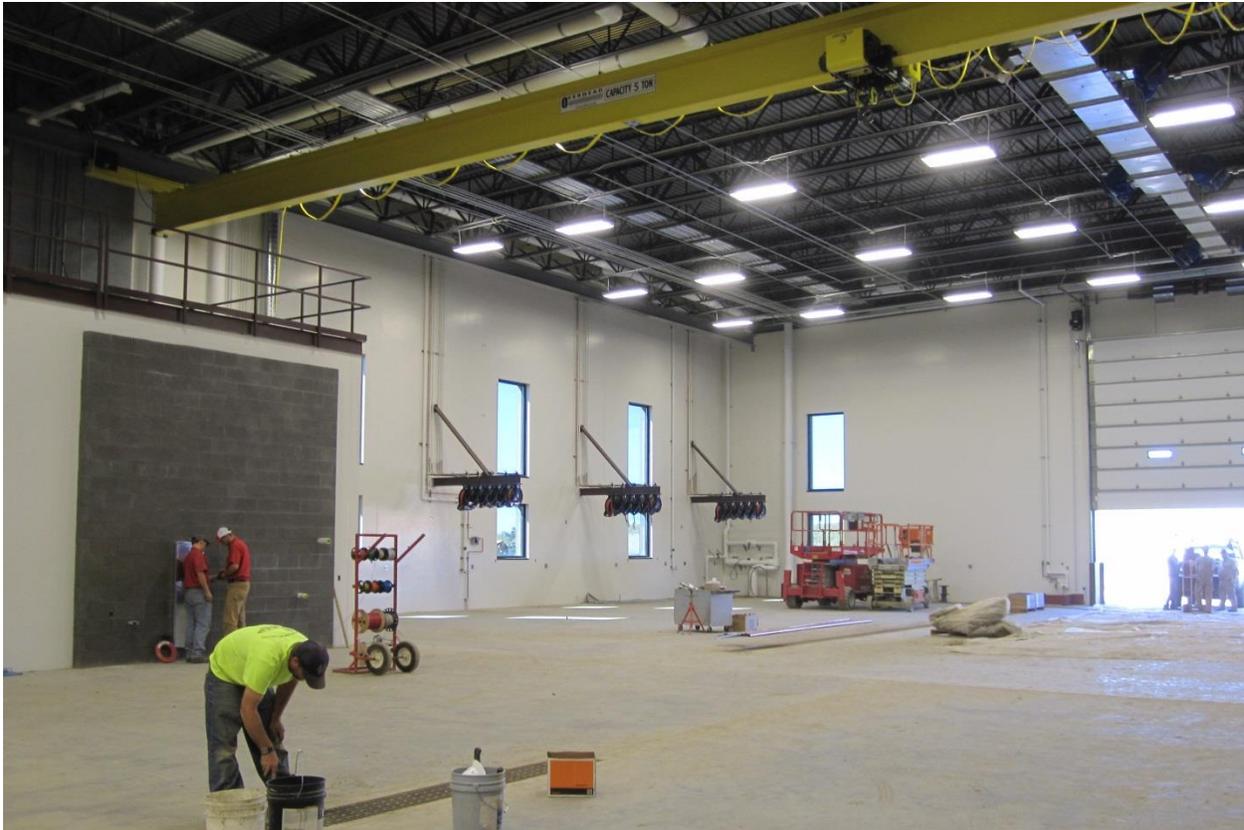
Photo 5: A view of the maintenance bay area with the bridge crane above and hose reels in the background.
